Exploring High-Baroque Stucco: Microscopy of Materials and Techniques at Kroměříž Chateau

Sylwia Svorová Pawełkowicz ^{a*}, Jan Válek ^a, Petr Kozlovcev ^a, Kristýna Kotková ^a, Dita Frankeová ^a

^a Institute of Theoretical and Applied Mechanics, Czech Academy of Sciences, (Prague), Czech Republic

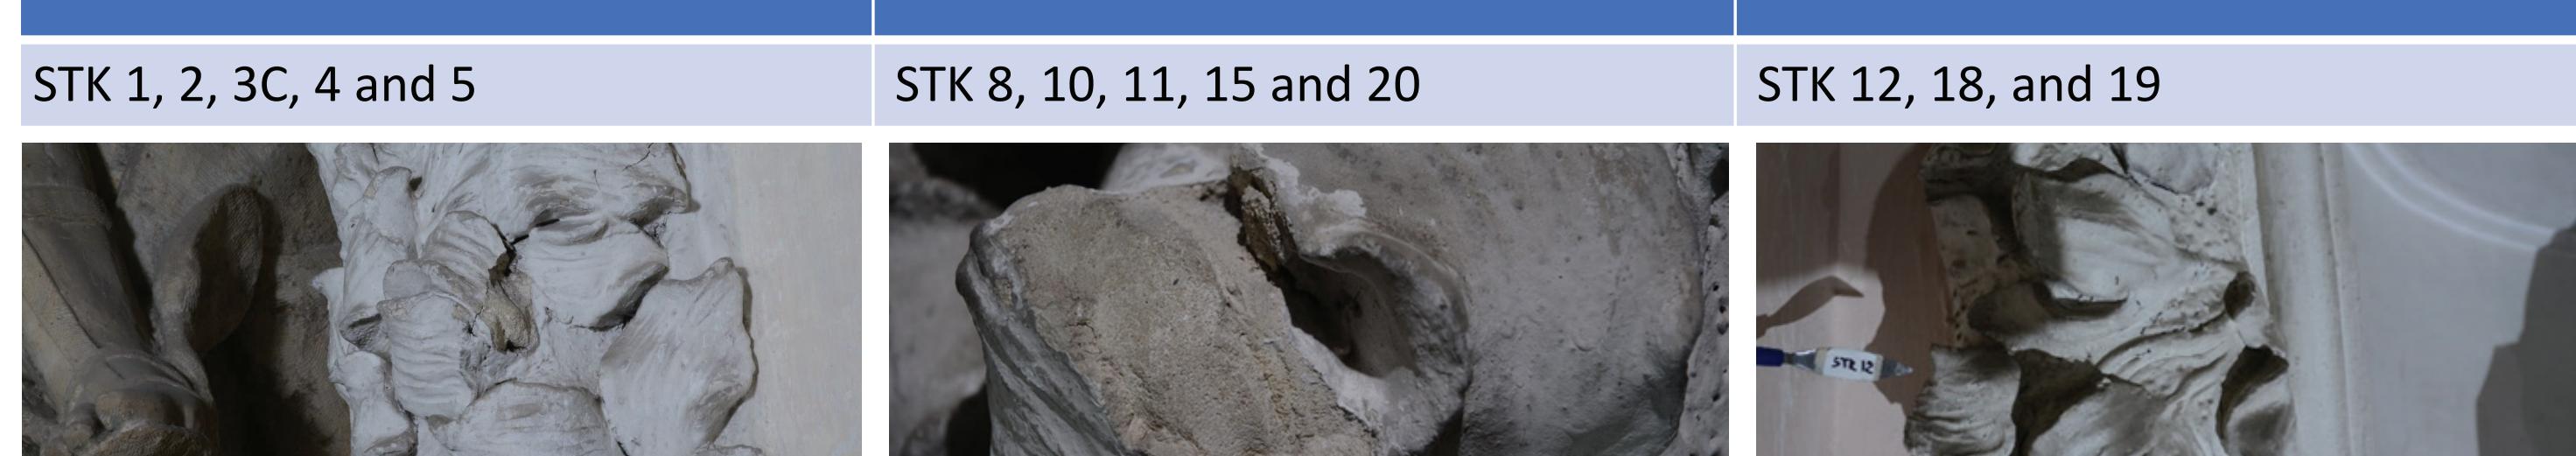
Extraction site of sample STK 2. ©PM. Extraction site of sample STK 8. ©JV.

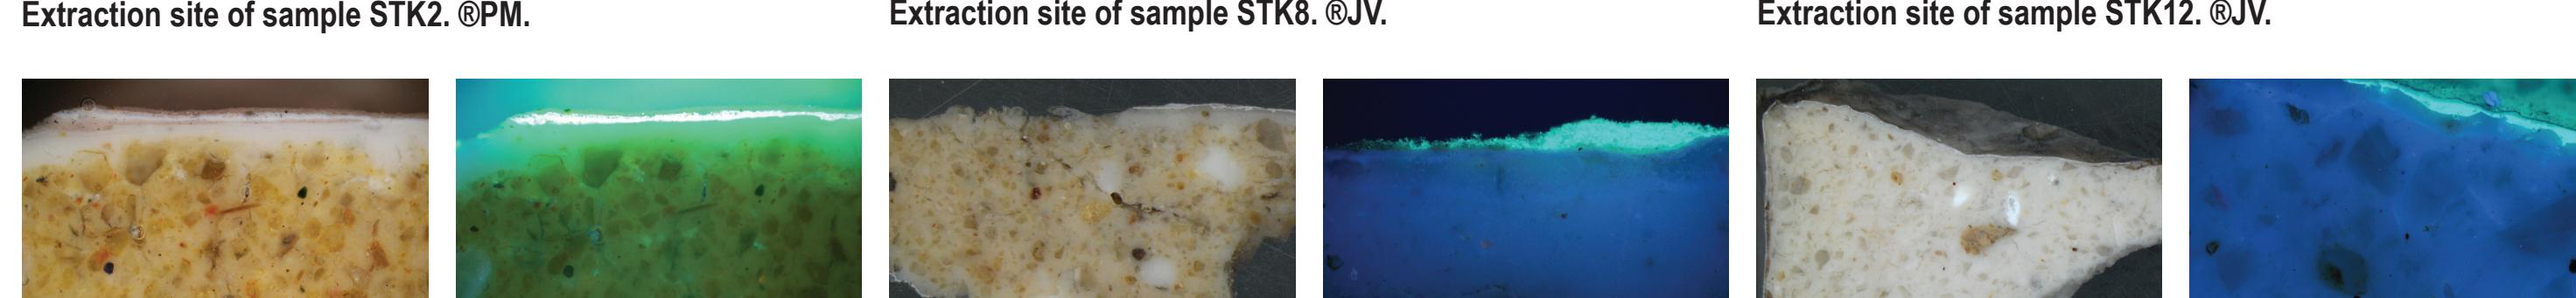
In the first subgroup (I) a typical siliciclastic aggregate composed of quartz grains, feldspars (albite), dark micas (biotite) and accessory opaque minerals was identified. The shape of the grains is irregular, sharp-angled, and often cracked.

In the second subgroup (II), in addition to the main siliciclastic component of the aggregate, significant amounts of marble clasts are present in samples STK 8, 10, 11, 15 and 20. These are sharp-angled, irregular fragments of coarsely crystalline marble with frequent twinning of grains. The marble fragments differ in grain size from the siliciclastic ones present, which may indicate separate production and sieving of these two aggregates.

In the third subgroup (III), crushed marble has replaced siliceous sand. These are samples of the leaves decorating the niches in the North Hall.

Cross section of sample STK2.©SP. STK2. UV. Mag. x50. ©SP. Cross section of sample STK8.©KK. STK8. UV. ©KK. Cross section of sample STK12.©SP. STK12. UV. ©KK.

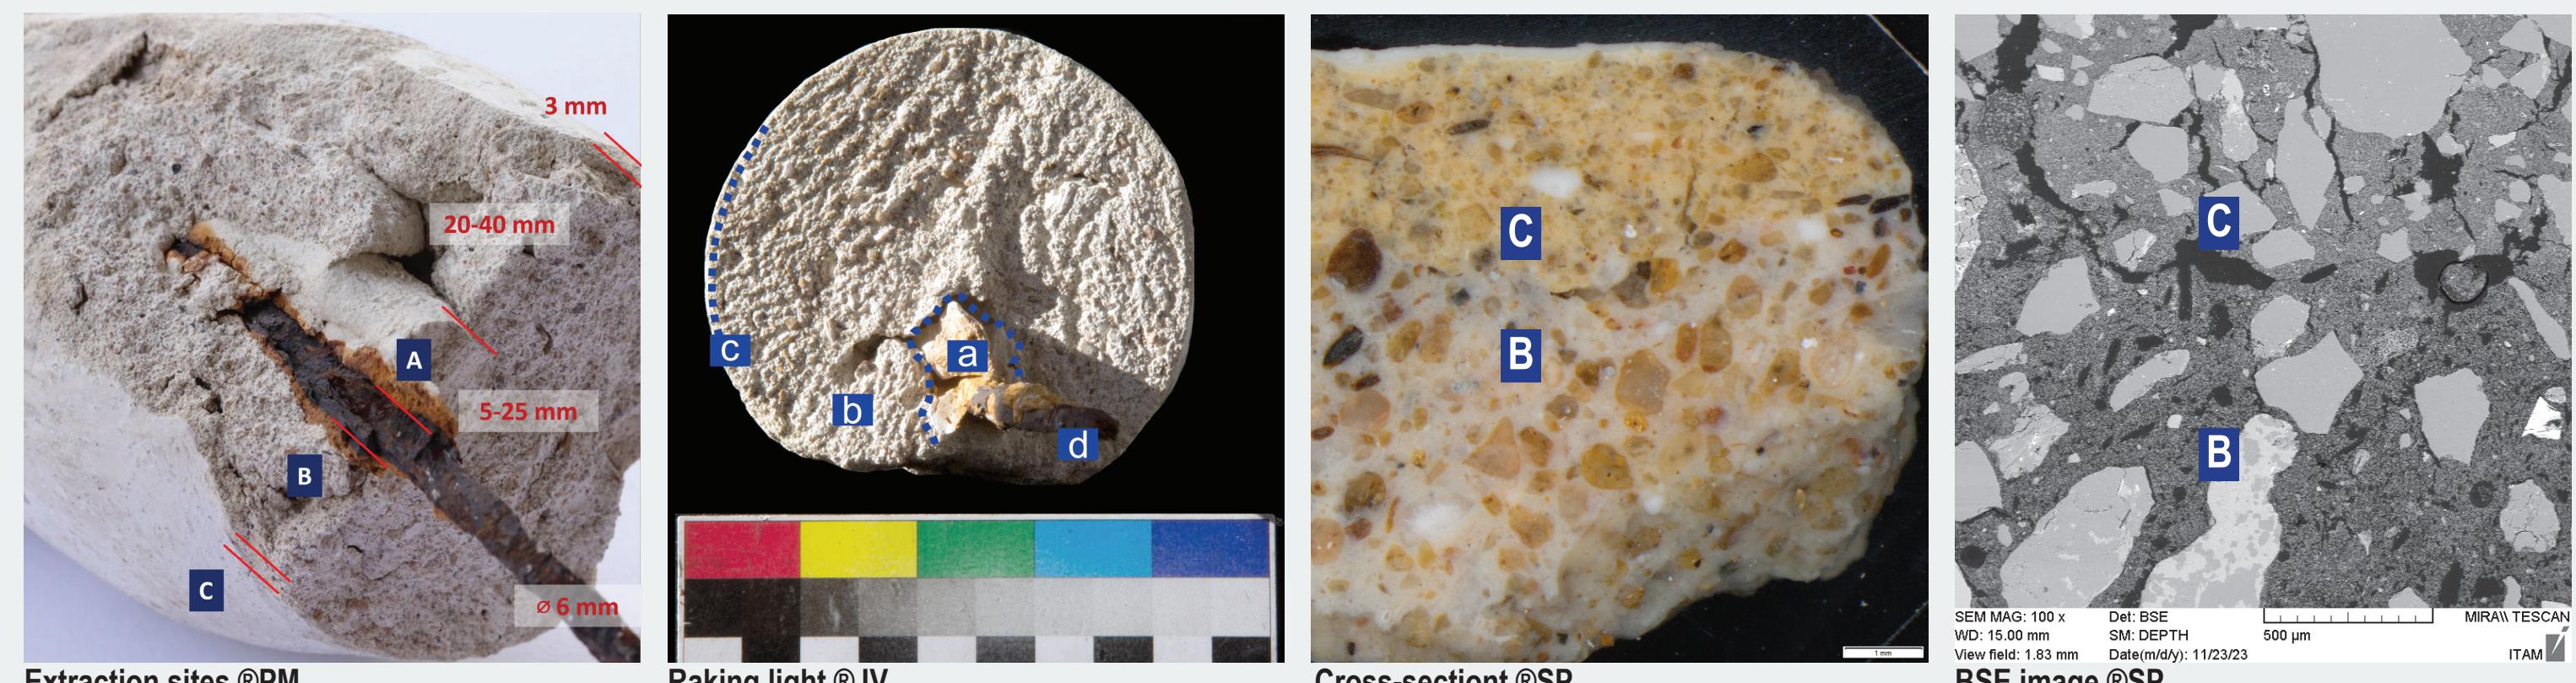
STK 3 - Section of putto's forearm

As the result of extreme damage, where part of the forearm of a putto was separated from the remaining torso due to corrosion of the internal supporting element, it was possible to study the construction of relief sculptures.

By studying the stratigraphy of the putto's broken forearm, it was possible to infer the construction sequence of this relief sculpture. The detached stucco fragment was about 8 cm in diameter and had an iron skeleton element (forged roughly to 4 x 6 mm) encased in a gypsum layer of variable thickness of 4 to 15 mm. A sample of this material was labelled STK 3A. This layer was clearly distinguishable from the subsequent layer, as there was a 'cold joint' between them—in some areas the two layers were not fully bonded. This indicated that the next layer was applied after the first had set. The second layer was between 10 and 40 mm thick. It consisted of several sub-layers that were very well bonded and not easily distinguishable, thus it was considered one material for the analysis. The sample of this layer was denoted STK 3B. A third layer was the final stucco layer. It was approximately 4 to 6 mm thick and was distinguishable by a finer structure (aggregate). The sample of this layer was labelled STK 3C.

The skeleton of the relief sculpture is made of forged iron. The first layer composed of gypsum mortar with a very low amount of lime, was applied directly onto the iron. This layer served as a bonding bridge between the iron and the core modelling mortar, which significantly stiffened the entire skeleton. While this hypothesis cannot be verified through material analysis, the mass of the successive layers suggests that a solid base was absolutely necessary. The main body mass was modelled in layers until he desired shape and proportions were reached. The layers were not regular but were very well bonded; their interfaces were visible only in some sections. This indicates wet-on-wet application until the body part was completed in a single stage.

- a – gypsum layer,
- b – core mortar,
- c – finishing stucco,
- d – forged iron bar.

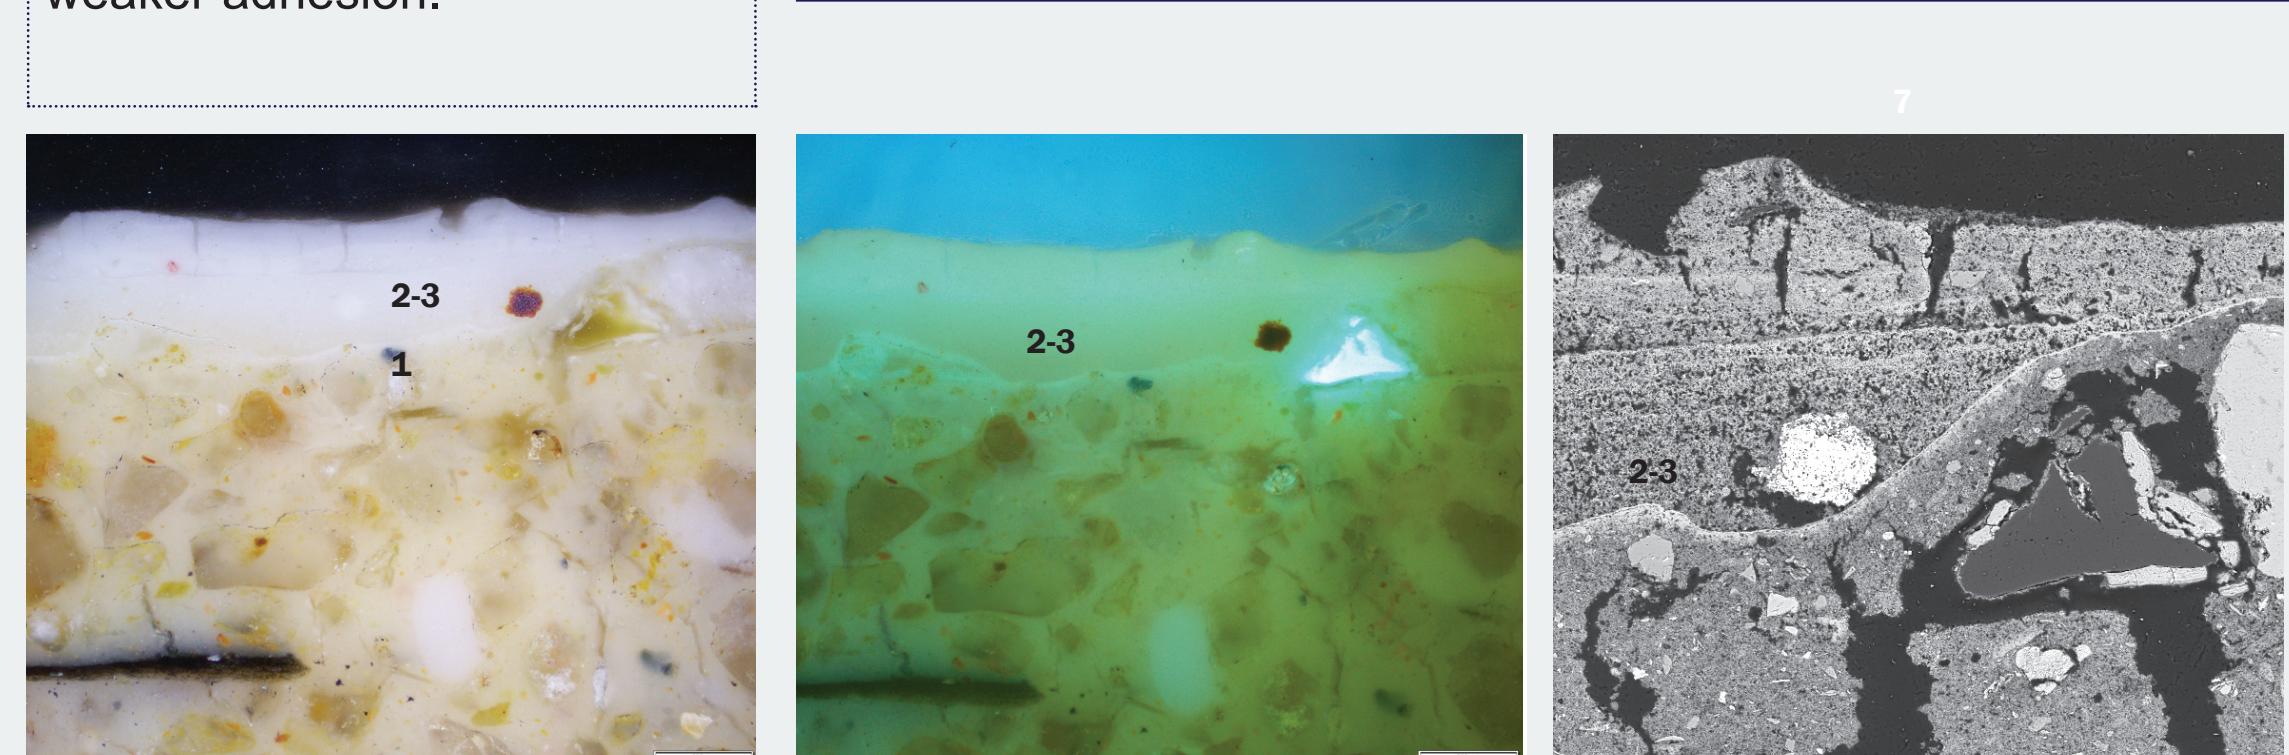
The first coat of paint on the stucco was a limewash which typically consisted of two to three application layers. The transitions between these application layers were barely perceptible with both the optical and electron microscopes, indicating that the craftsman applied multiple layers of limewash wet-on-wet. Clear difference in luminescence in UV light was noted between the first limewash and the subsequent coatings composed of limewashes and paint layers. There are distinct morphological differences between the first and successive limewashes, the latter exhibiting more pronounced vertical cracks and weaker adhesion.

Transition between a lime-gypsum core mortar with a quantity of silica aggregate (upper layer) and a greyish coloured gypsum layer containing gypsum particles of varying degrees of processing (lower layer). Sample STK 3 A/B, PPL.

An unprocessed gypsum particle (bottom) and cracked quartz grains of the aggregate (top). In the upper right corner, brownish to rusty discolouration of the matrix due to contact with the iron reinforcement. Sample STK 3 B, PPL.
