## Summary of results

of  
material analysis of stucco decoration  
of cabinet and salon of

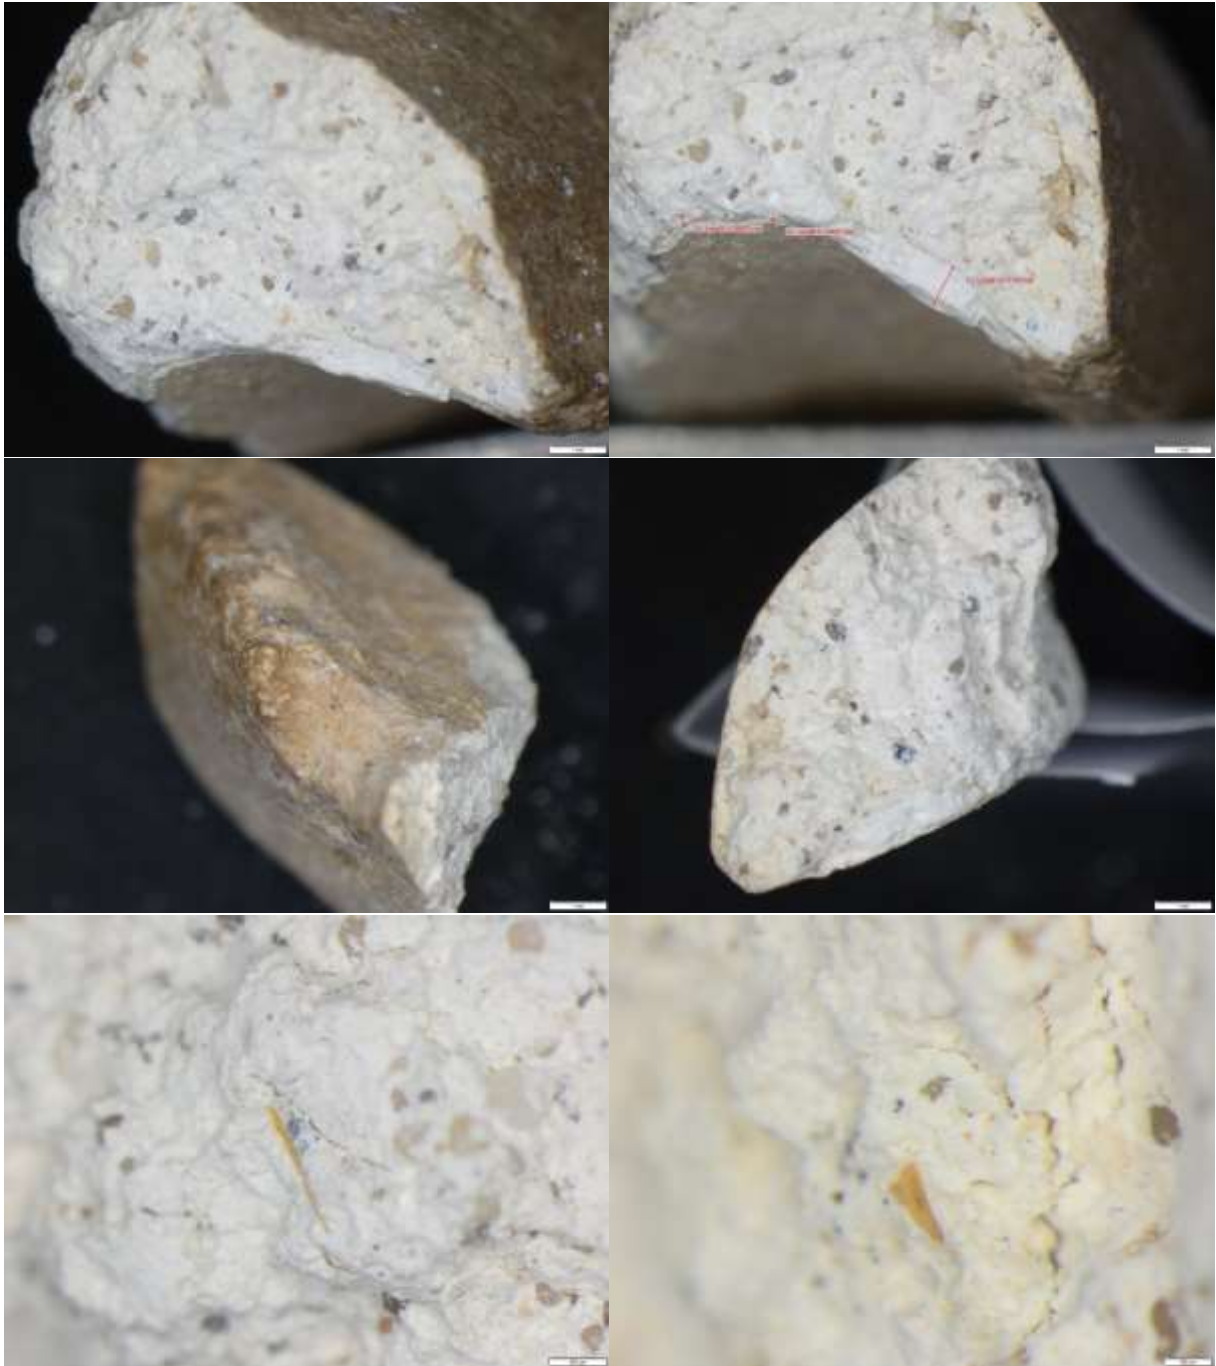
**Polished section**

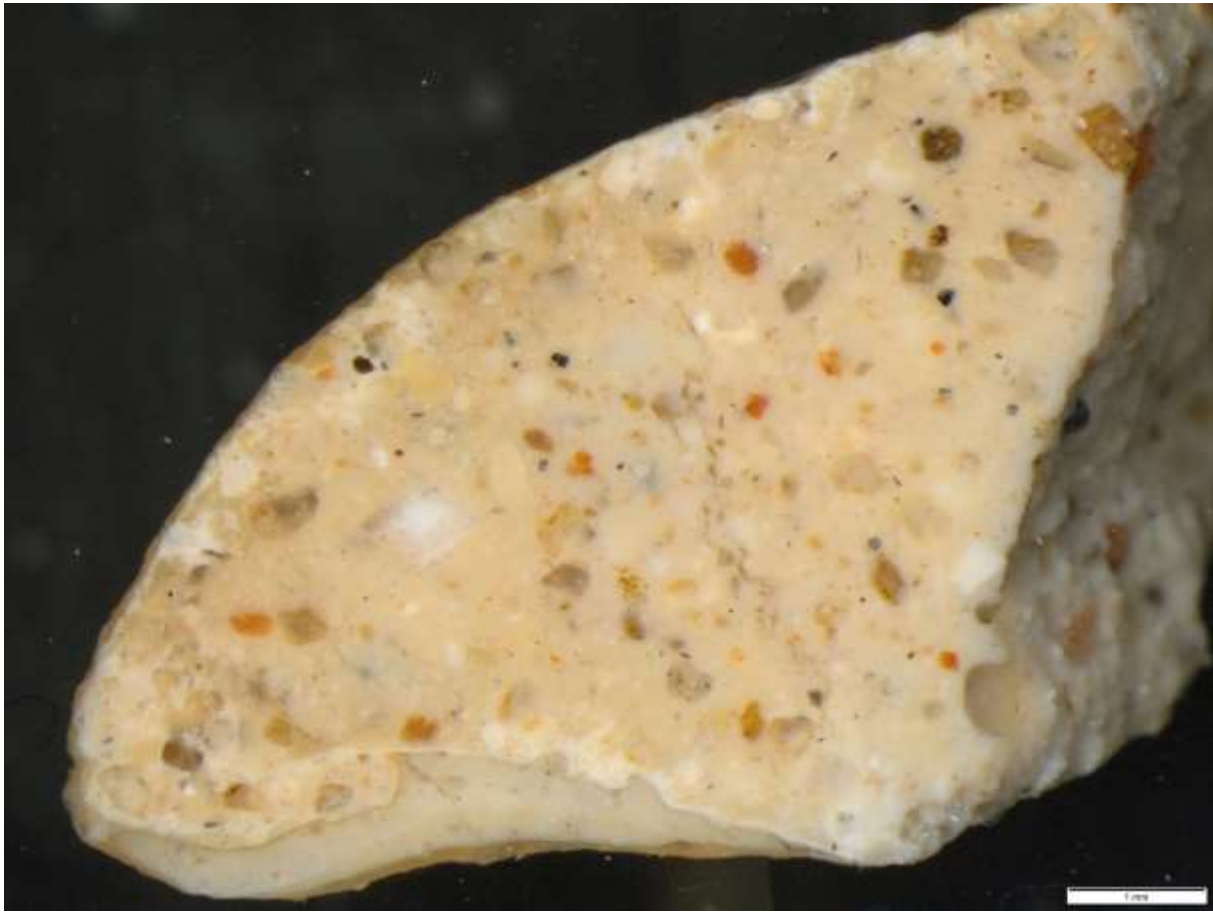
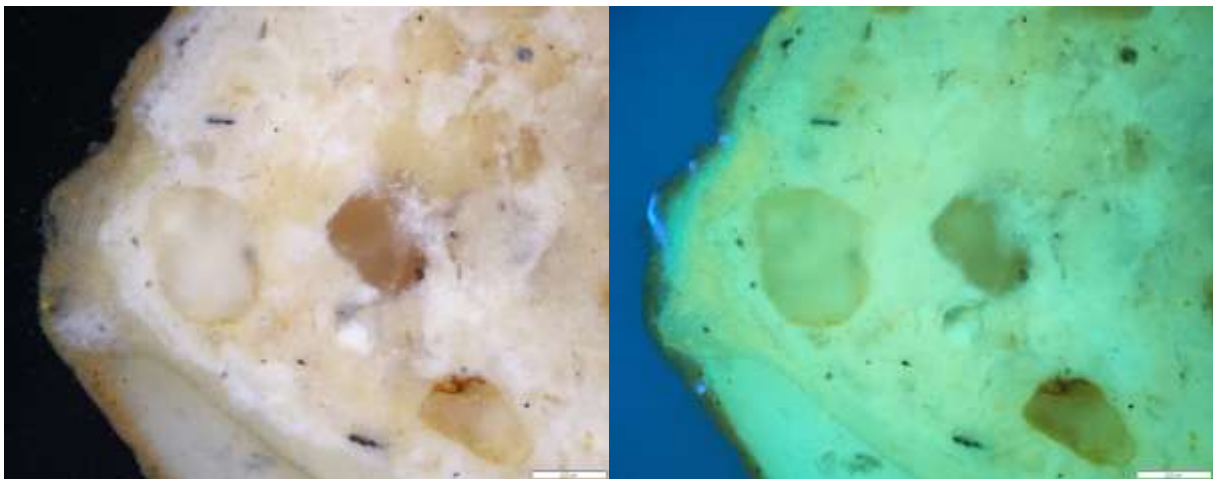
Detail of the tip. The mortar is coated, top layer is orange, as also visible on macroscopic scale.

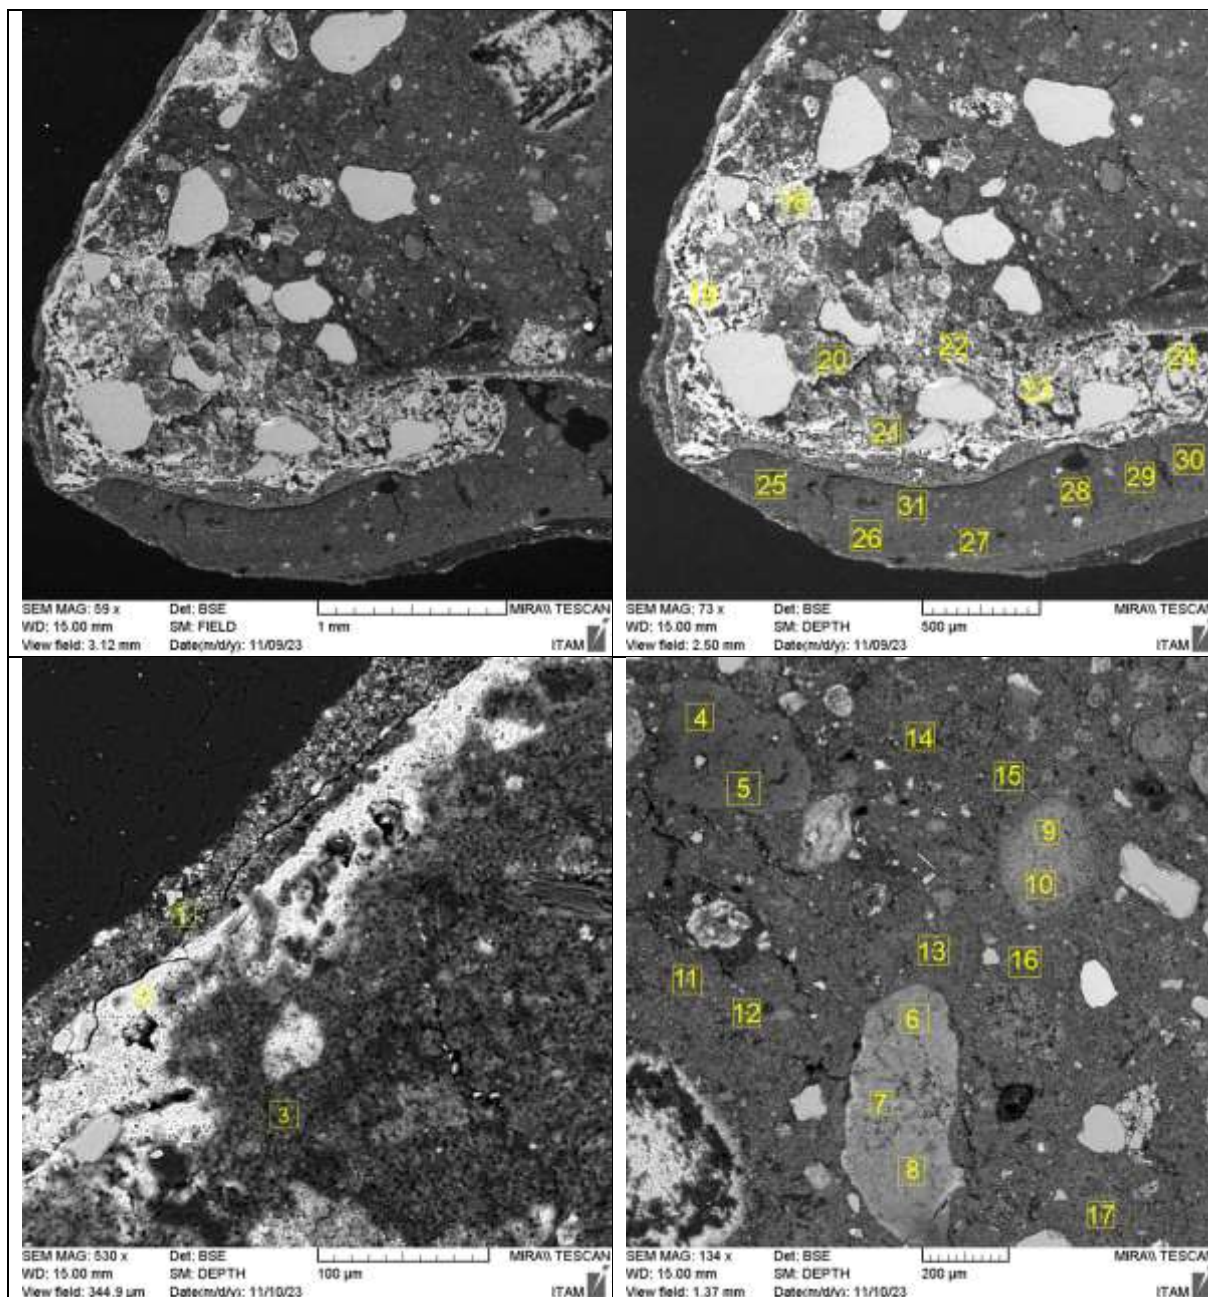
Table 1. Description of the layers observed in the cross-section SPH1.

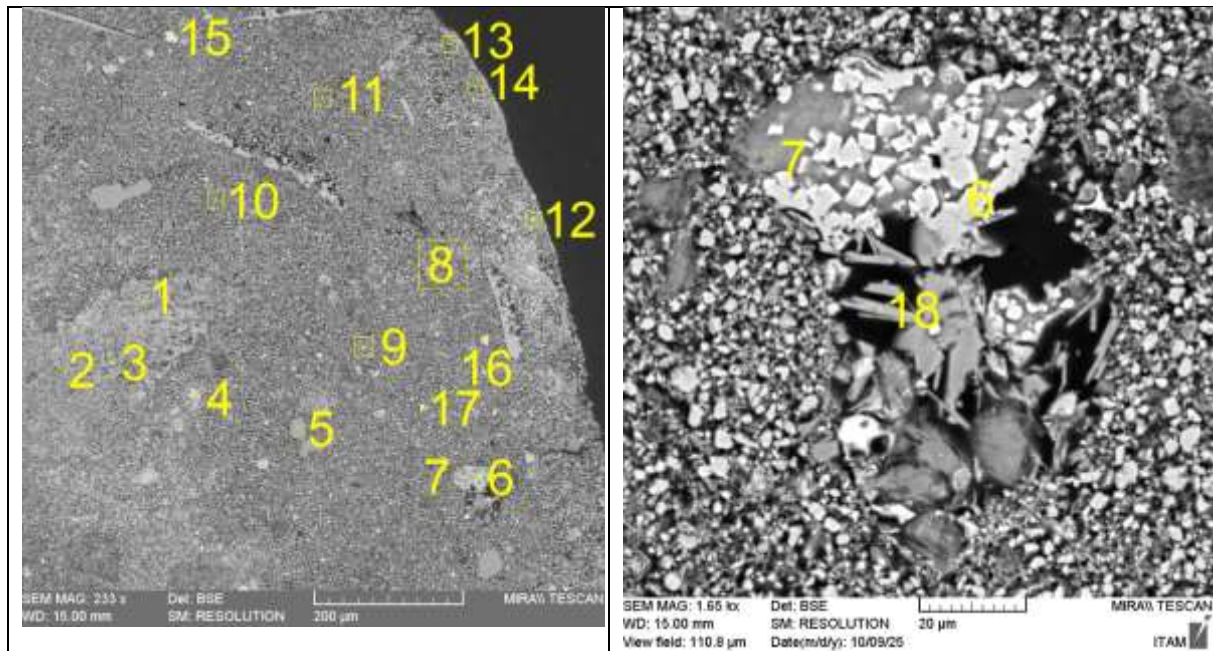
Table 3. Description of the layers observed in the cross-section SPH2.

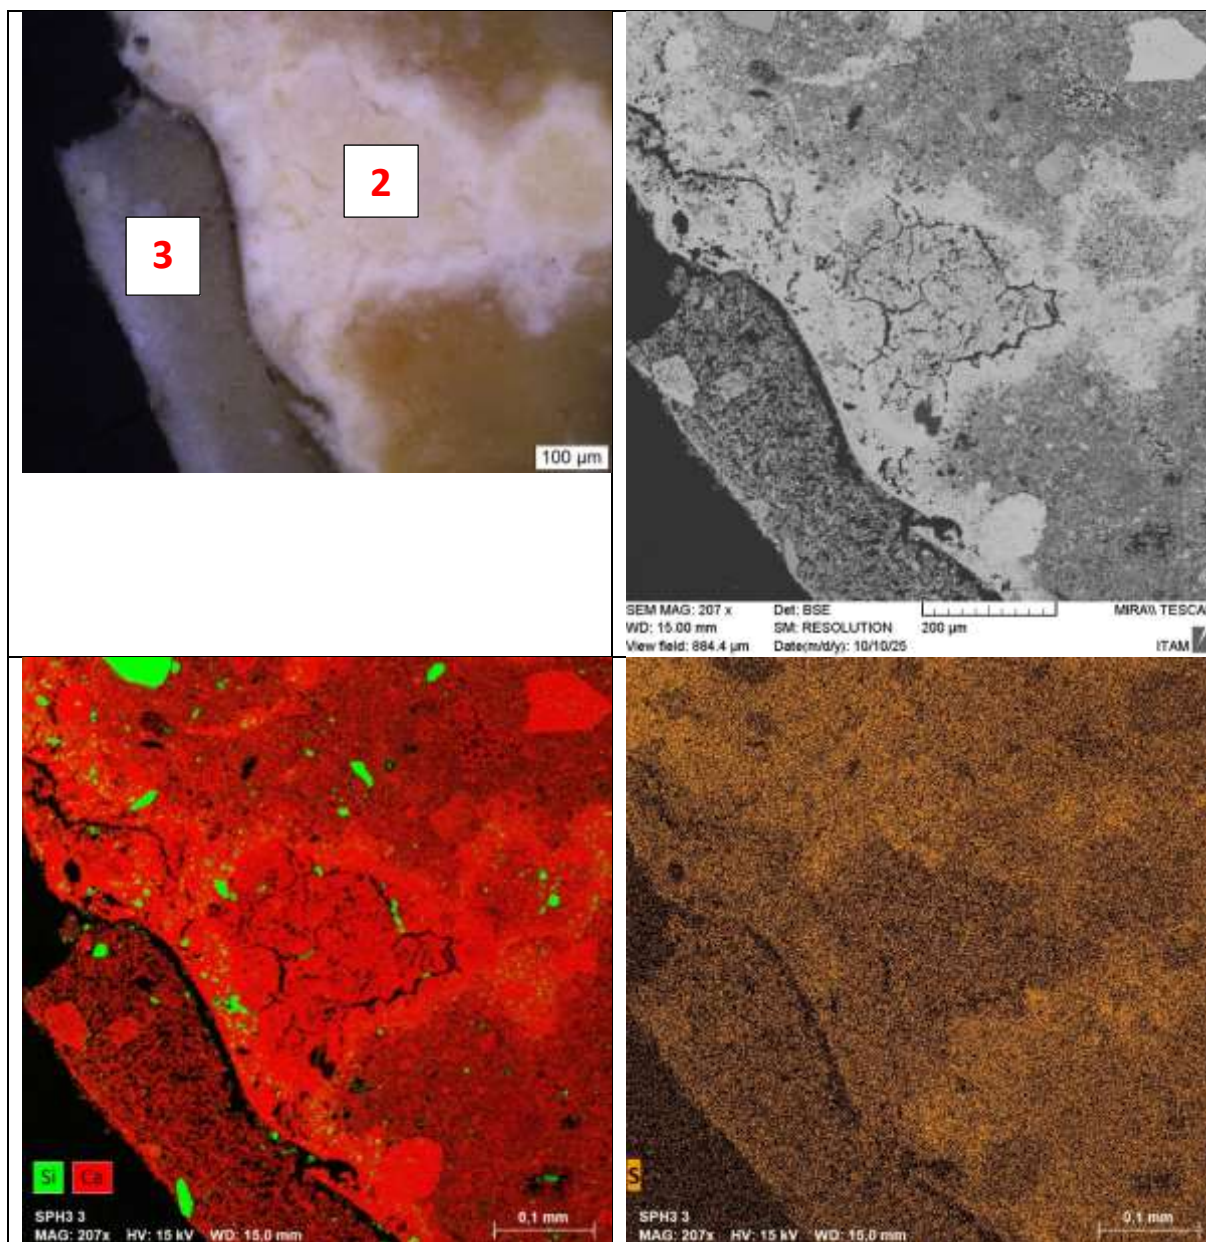
Table 5. Description of the layers observed in the cross-section SPH3.

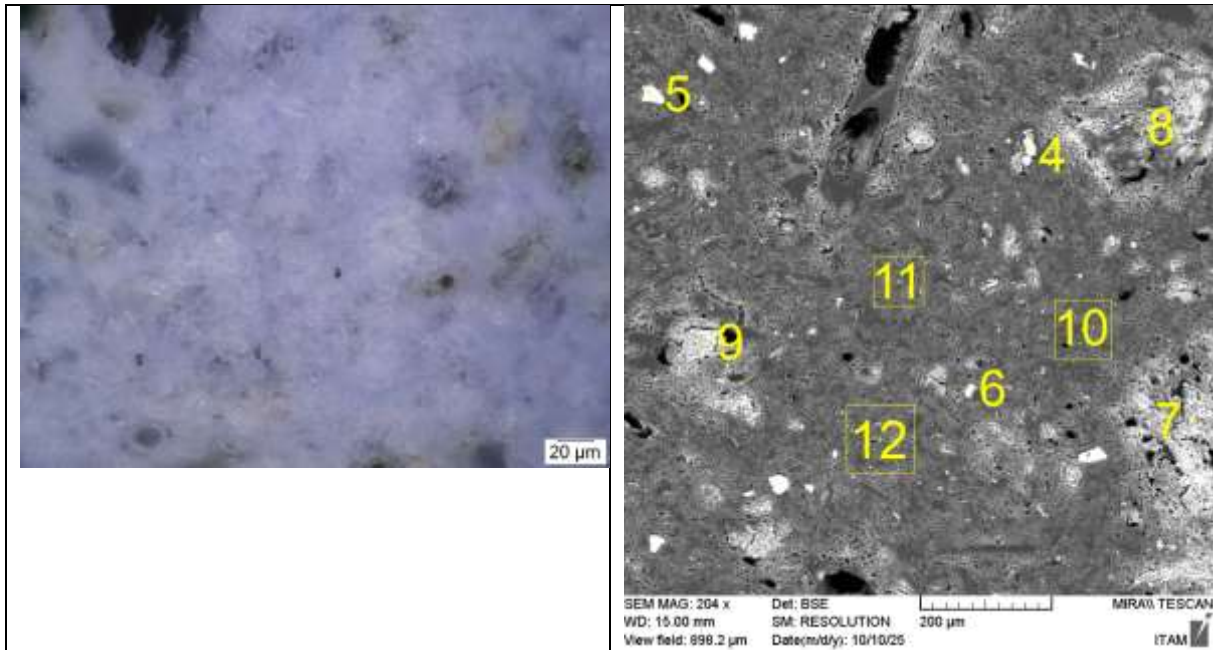
Table 7. Description of the layers observed in the cross-section SPH4.

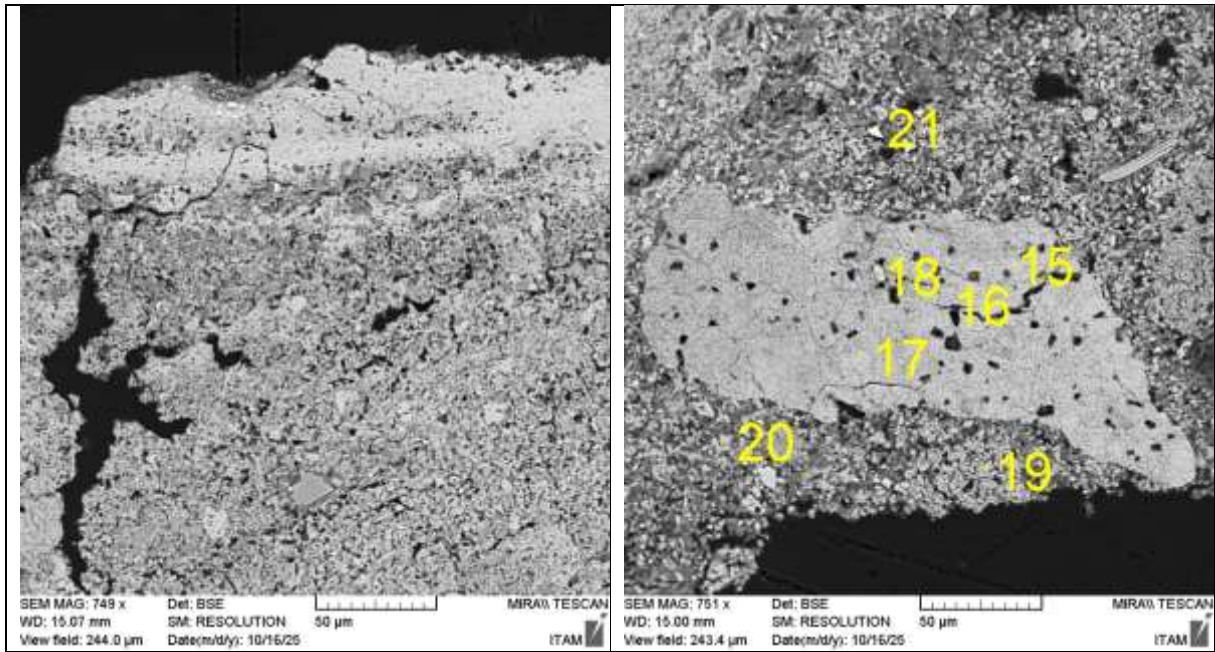
Table 9. Description of the layers observed in the cross-section SPH5a.

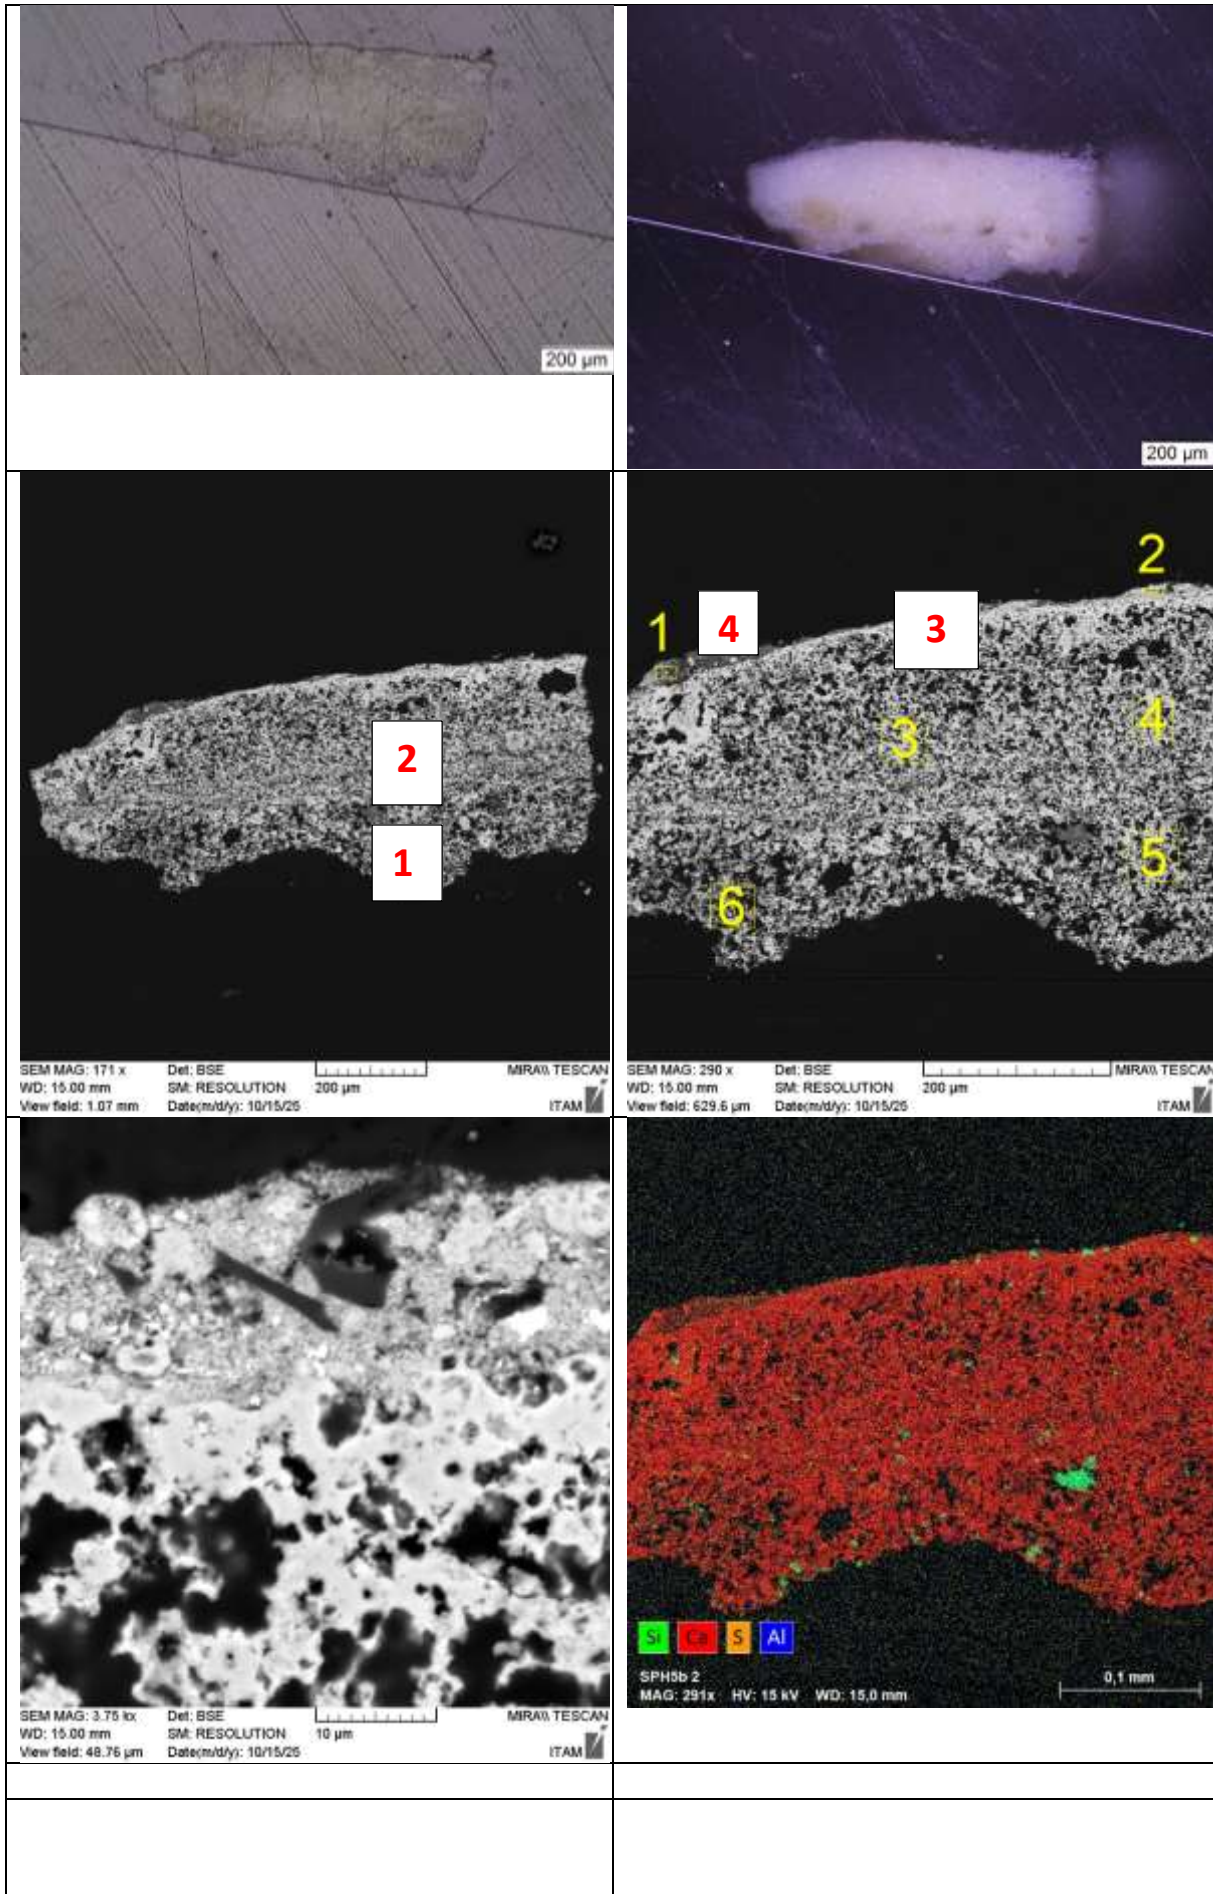
Table 11. Description of the layers observed in the cross-section SPH5b.

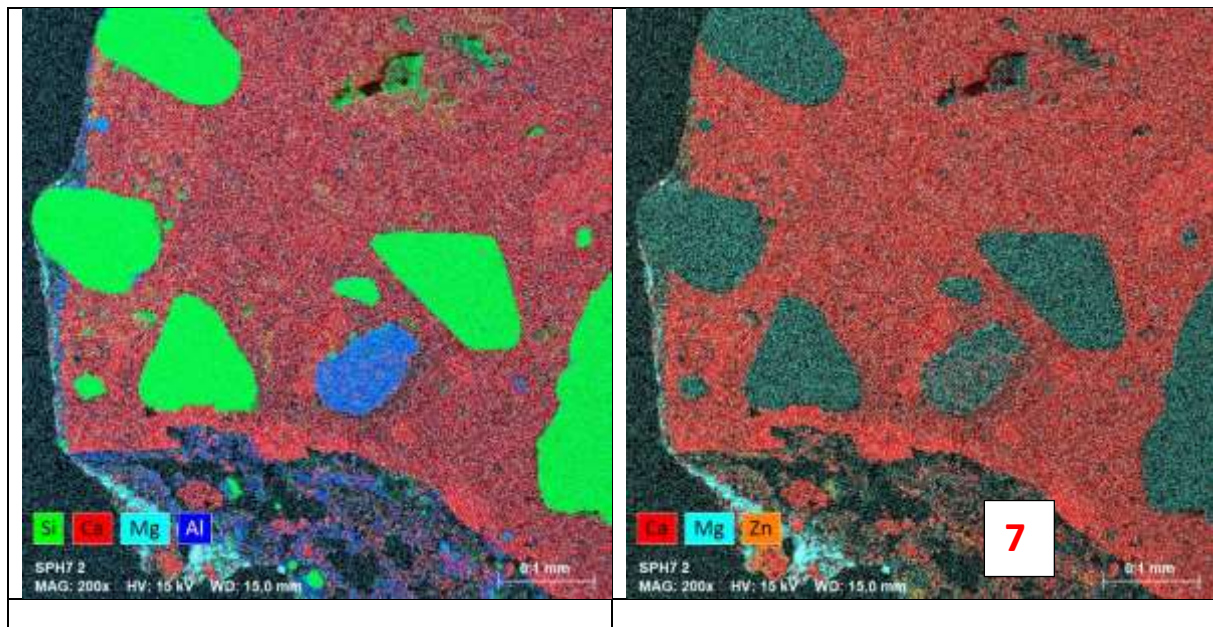
Table 13. Description of the layers observed in the cross-section SPH7.

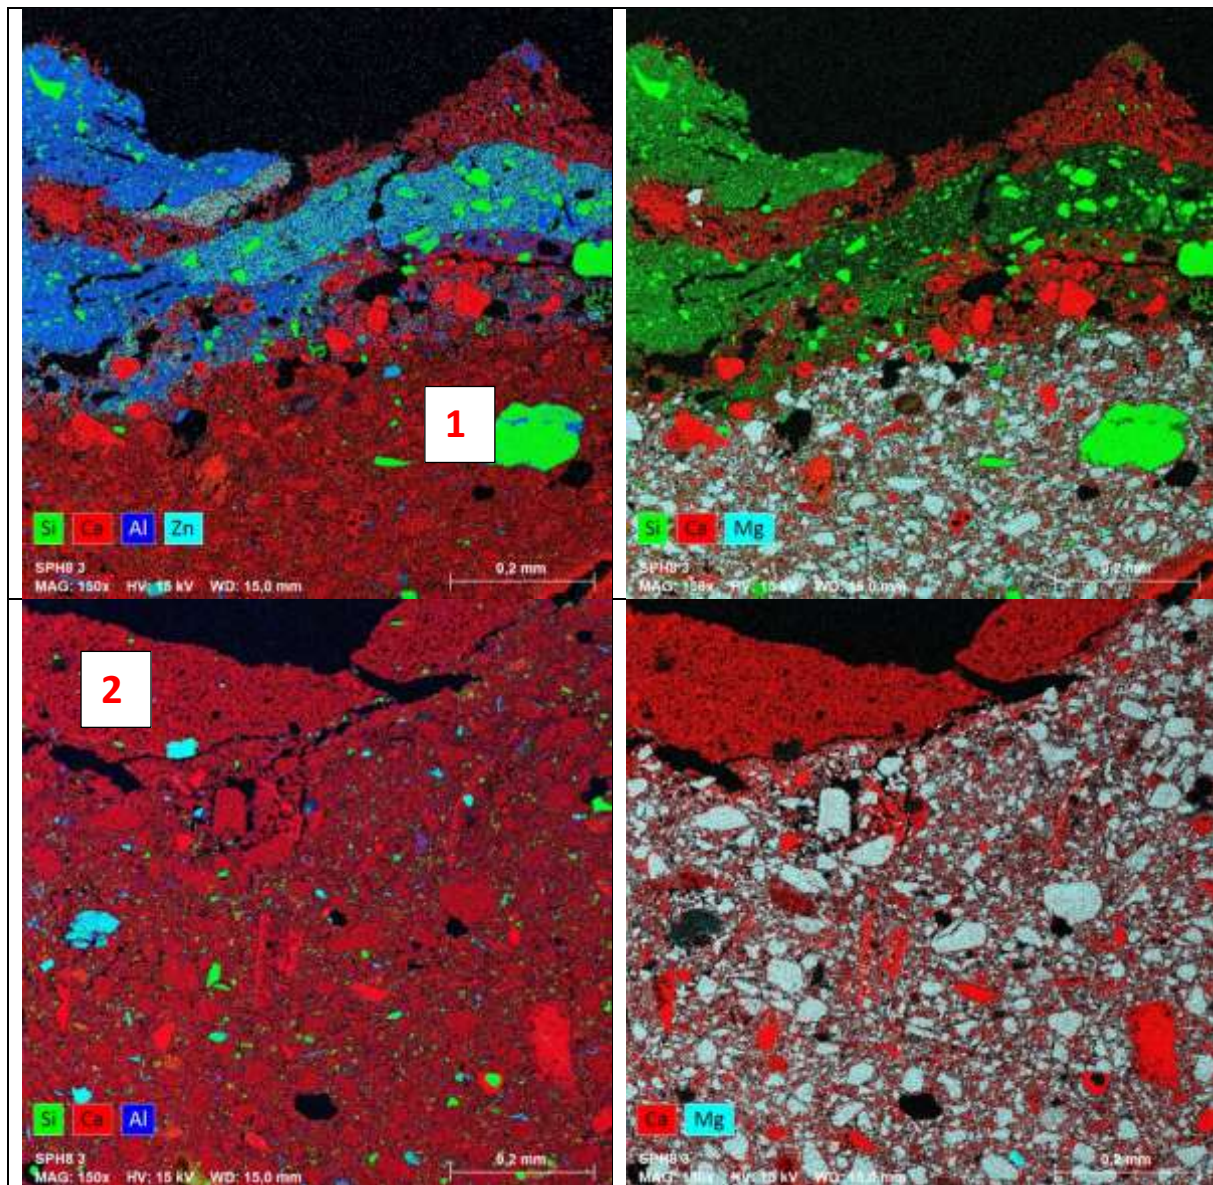
Table 15. Description of the layers observed in the cross-section SPH8.

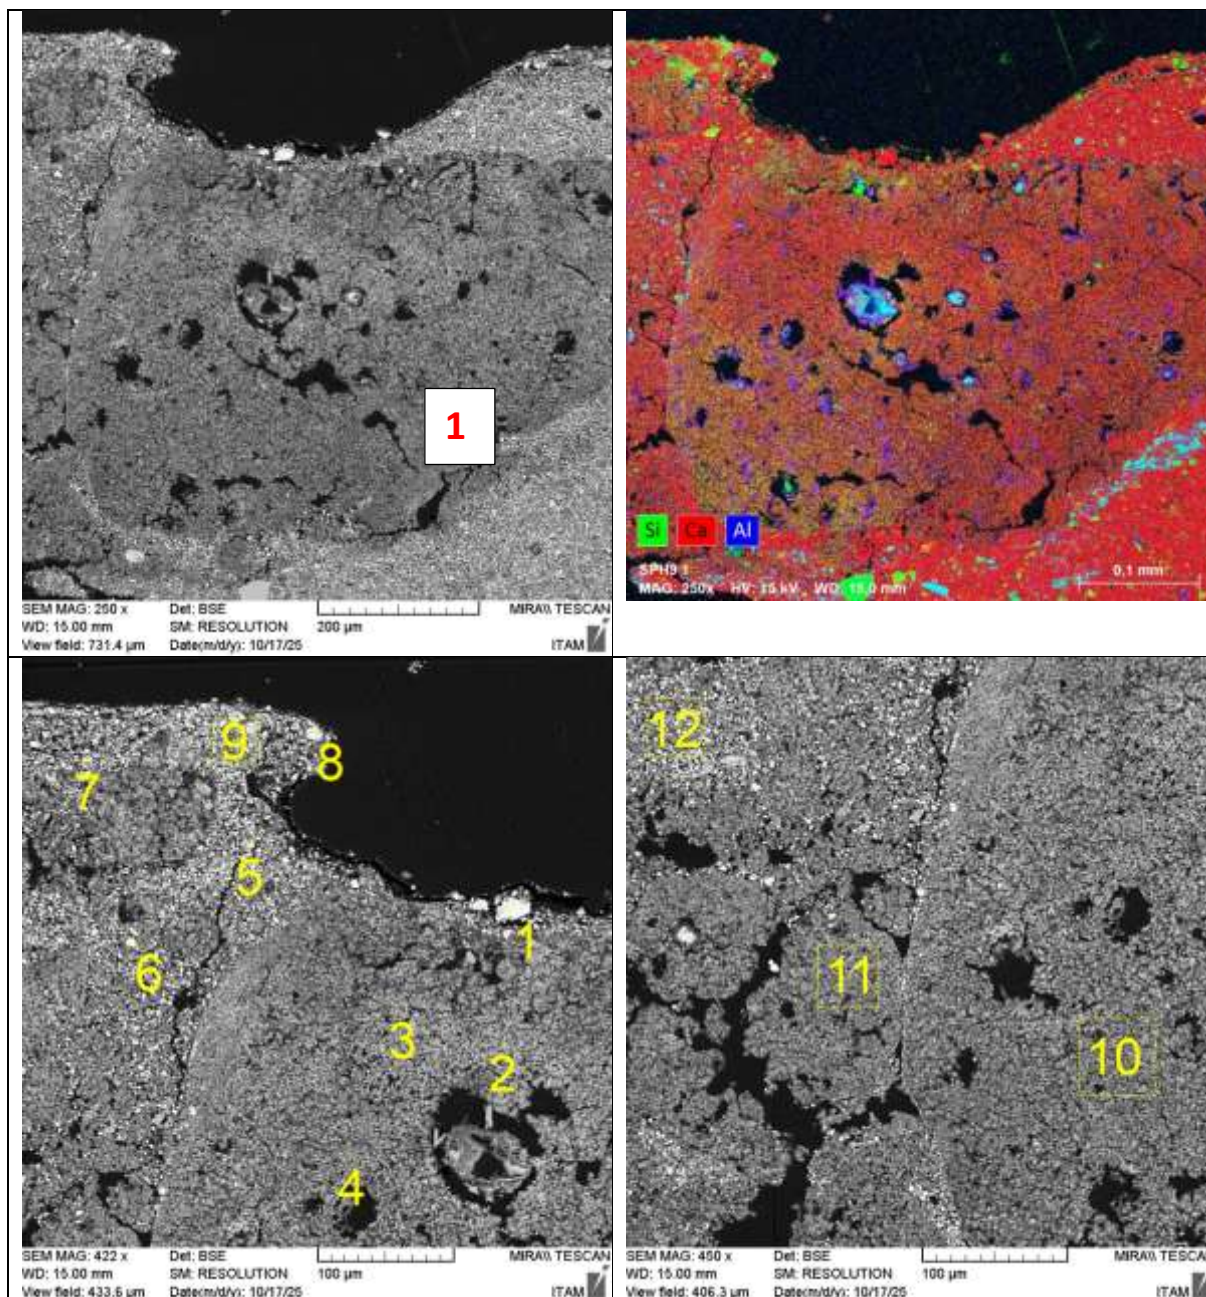
Table 17. Description of the layers observed in the cross-section SPH9.
