Project STUDEC (Stucco decorations across Europe)

Arogno (Ticino) Church of Santo Stefano

Results of the scientific characterization of stucco
decoration

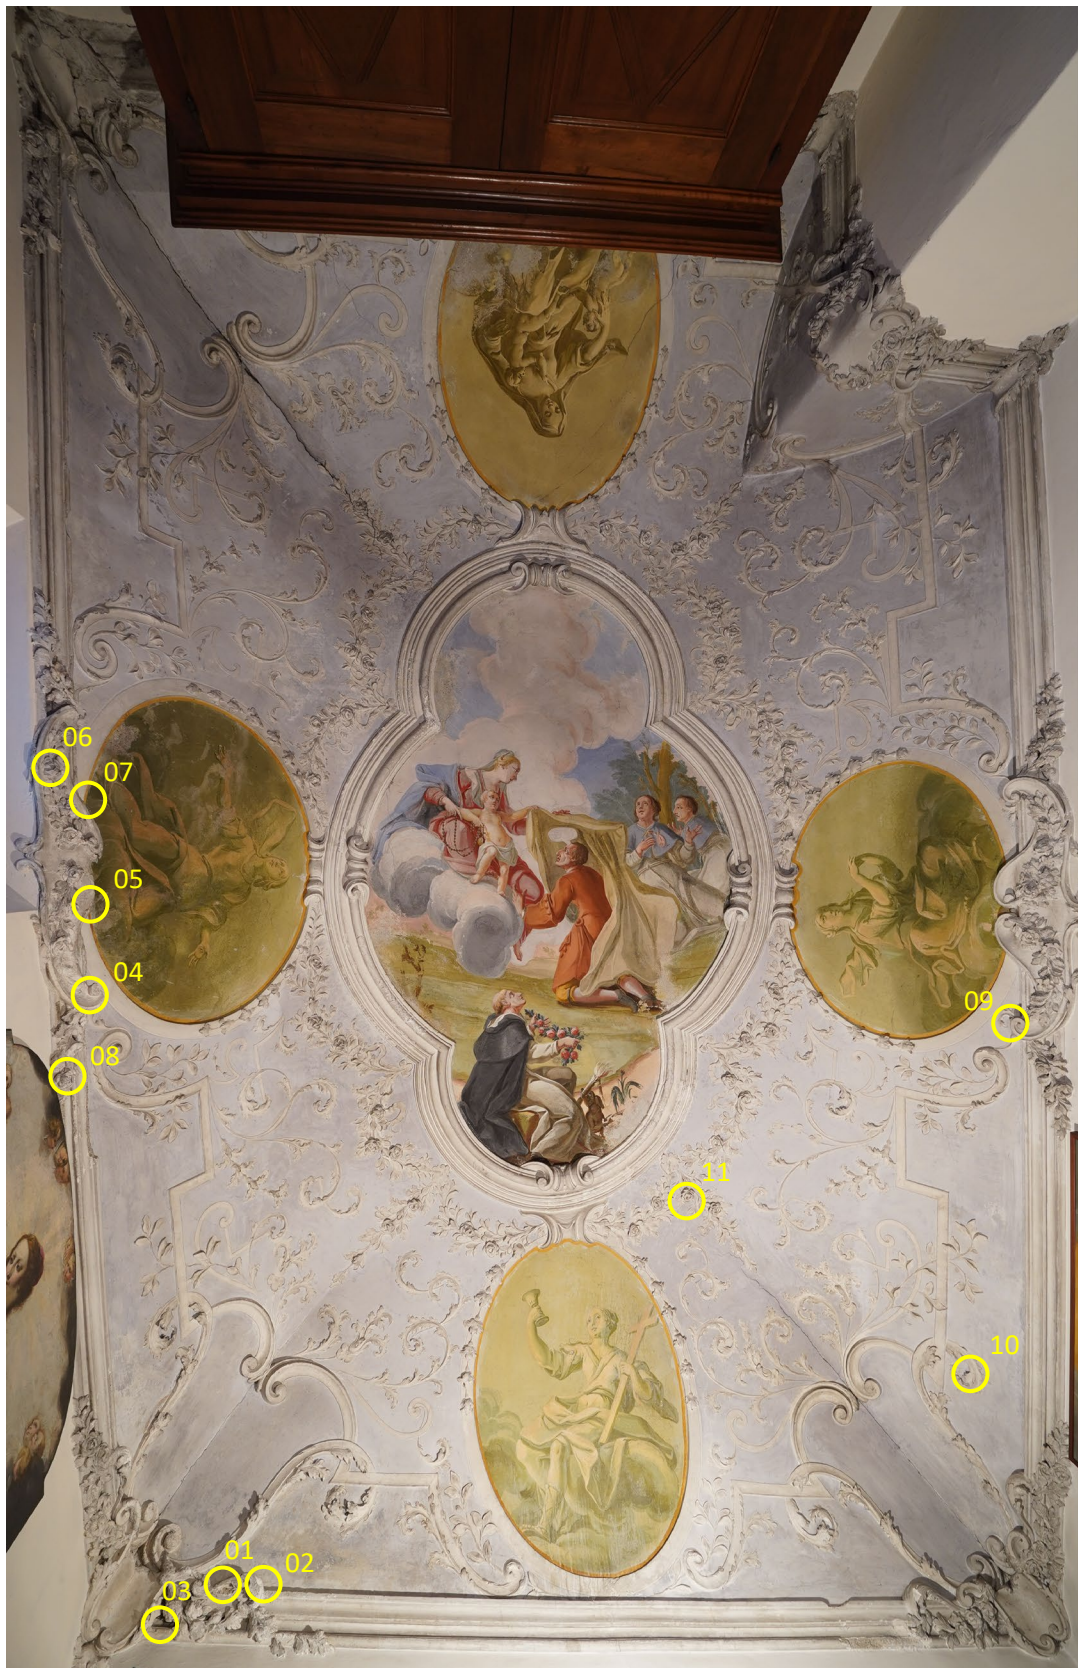
Female Chapel's vault, sampling points

The stucco decoration of the female chapel is mainly bas-relief, with some more protruding elements in the cornices and around the mural painting in the center of the vault.

The low relief stucco consists of a single finishing layer, while the high relief decoration consists of a ground layer and a finishing layer.

The ground layer contains Mg lime and gypsum as a binder, with lumps of both lime and gypsum. The amount of binder is higher than the amount of aggregate. The sand comes from a local river of the Mendrisio area and is composed of siliceous limestone, calcite and lower content of quartz-feldspar fractions.

The finishing layer is almost entirely made up of Mg-lime binder, with very frequent lime lumps (binder-related particles), without sand aggregate.

The stucco decoration, particularly in the south-east corner, is damaged by the action of soluble salts, probably due to previous roof infiltration. The salts analyzed were found to be epsomite $\text{MgSO}_4 \cdot 7\text{H}_2\text{O}$, a very soluble salt that caused the disintegration and loss of material.

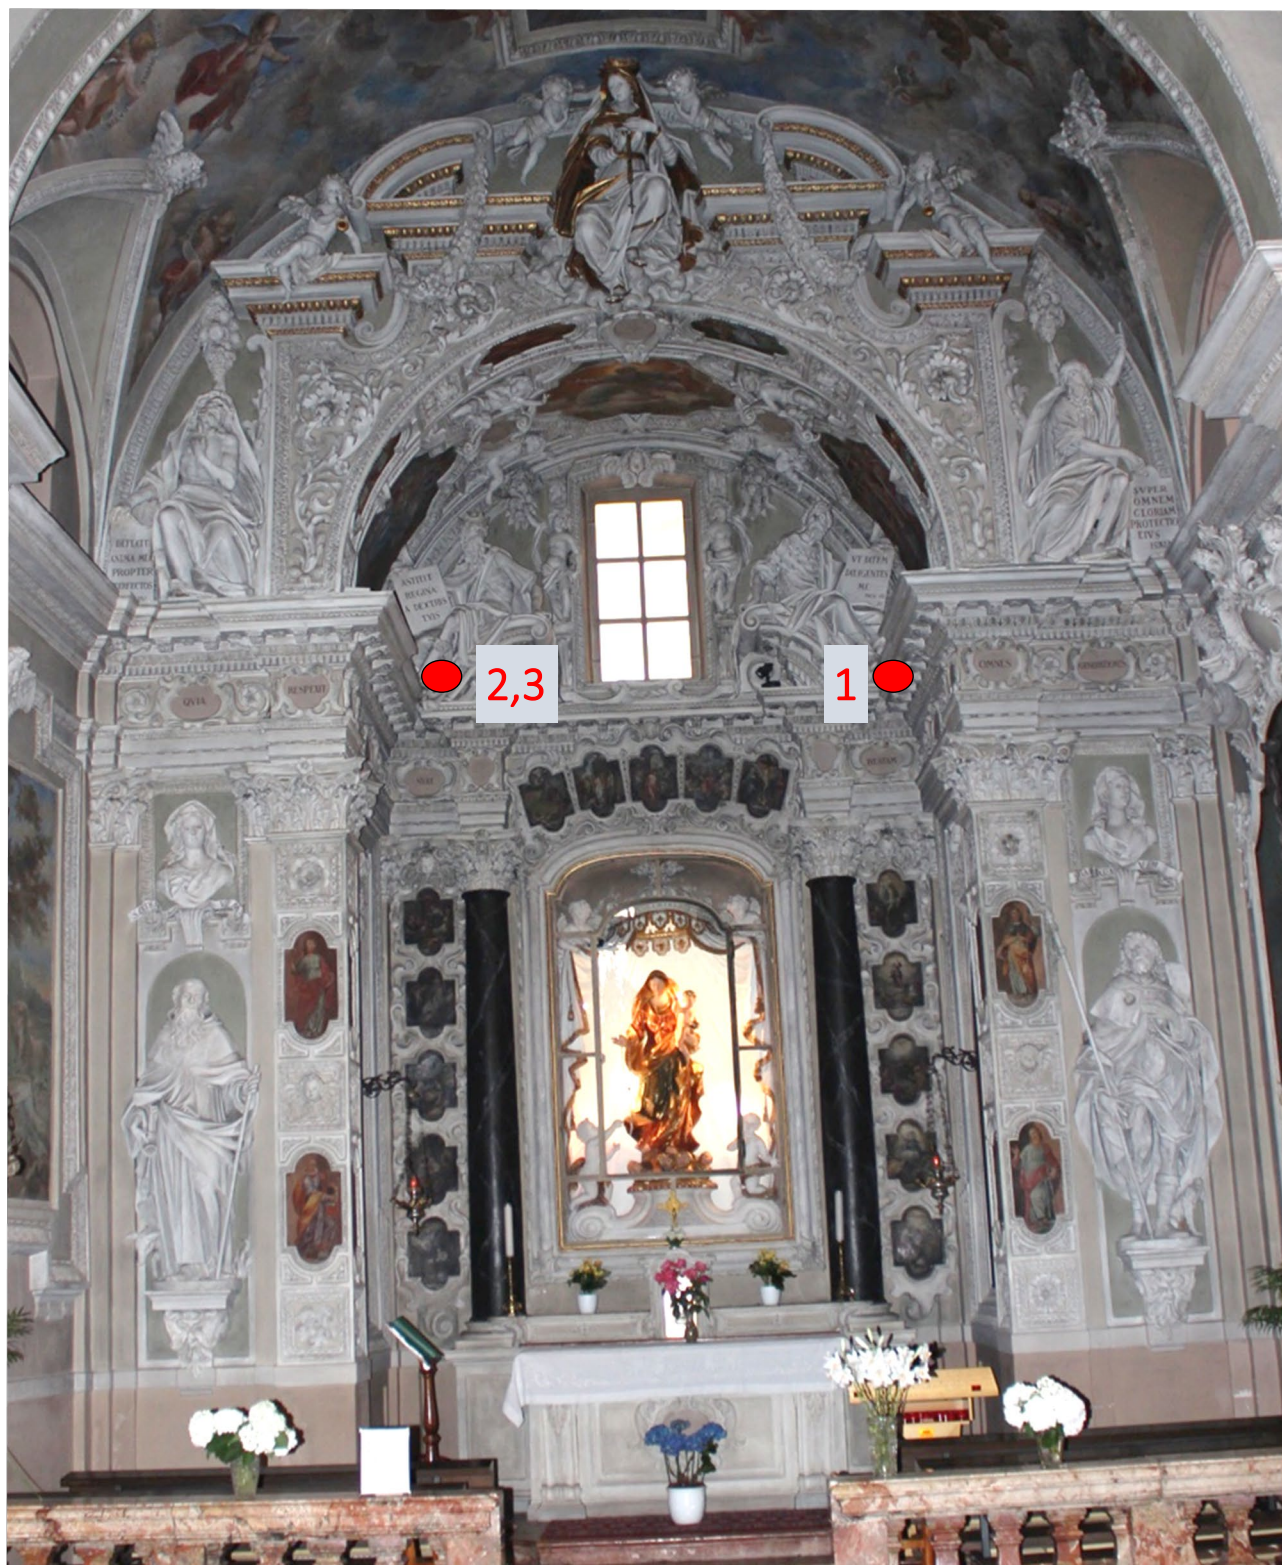
Rosario chapel, sampling points

The wall behind the altar in the Rosario Chapel.

The stucco decoration of the **statues of the prophets** of the Rosario chapel are composed of a ground and a finishing layer.

The ground layer has a binder composed of magnesia lime, which often contains lime lumps. Gypsum is consistently present in the composition. The lime-to-aggregate ratio (L/A) is 1:1. The aggregate consists of coarse and very coarse sand, moderately sorted. The composition includes flinty limestone, fragments of metamorphic silicate rocks, and gypsum fragments. The porosity is medium, and the shapes of the particles are irregular, sometimes resulting in shrinkage cracks.

For the finishing layer, the binder is also magnesia lime, but with a much higher frequency of lime lumps. Gypsum is again consistently present. The lime-to-aggregate ratio (L/A) is much higher than 1, with the mixture being almost entirely binder. The aggregate is not present but there are burnt limestone and gypsum.

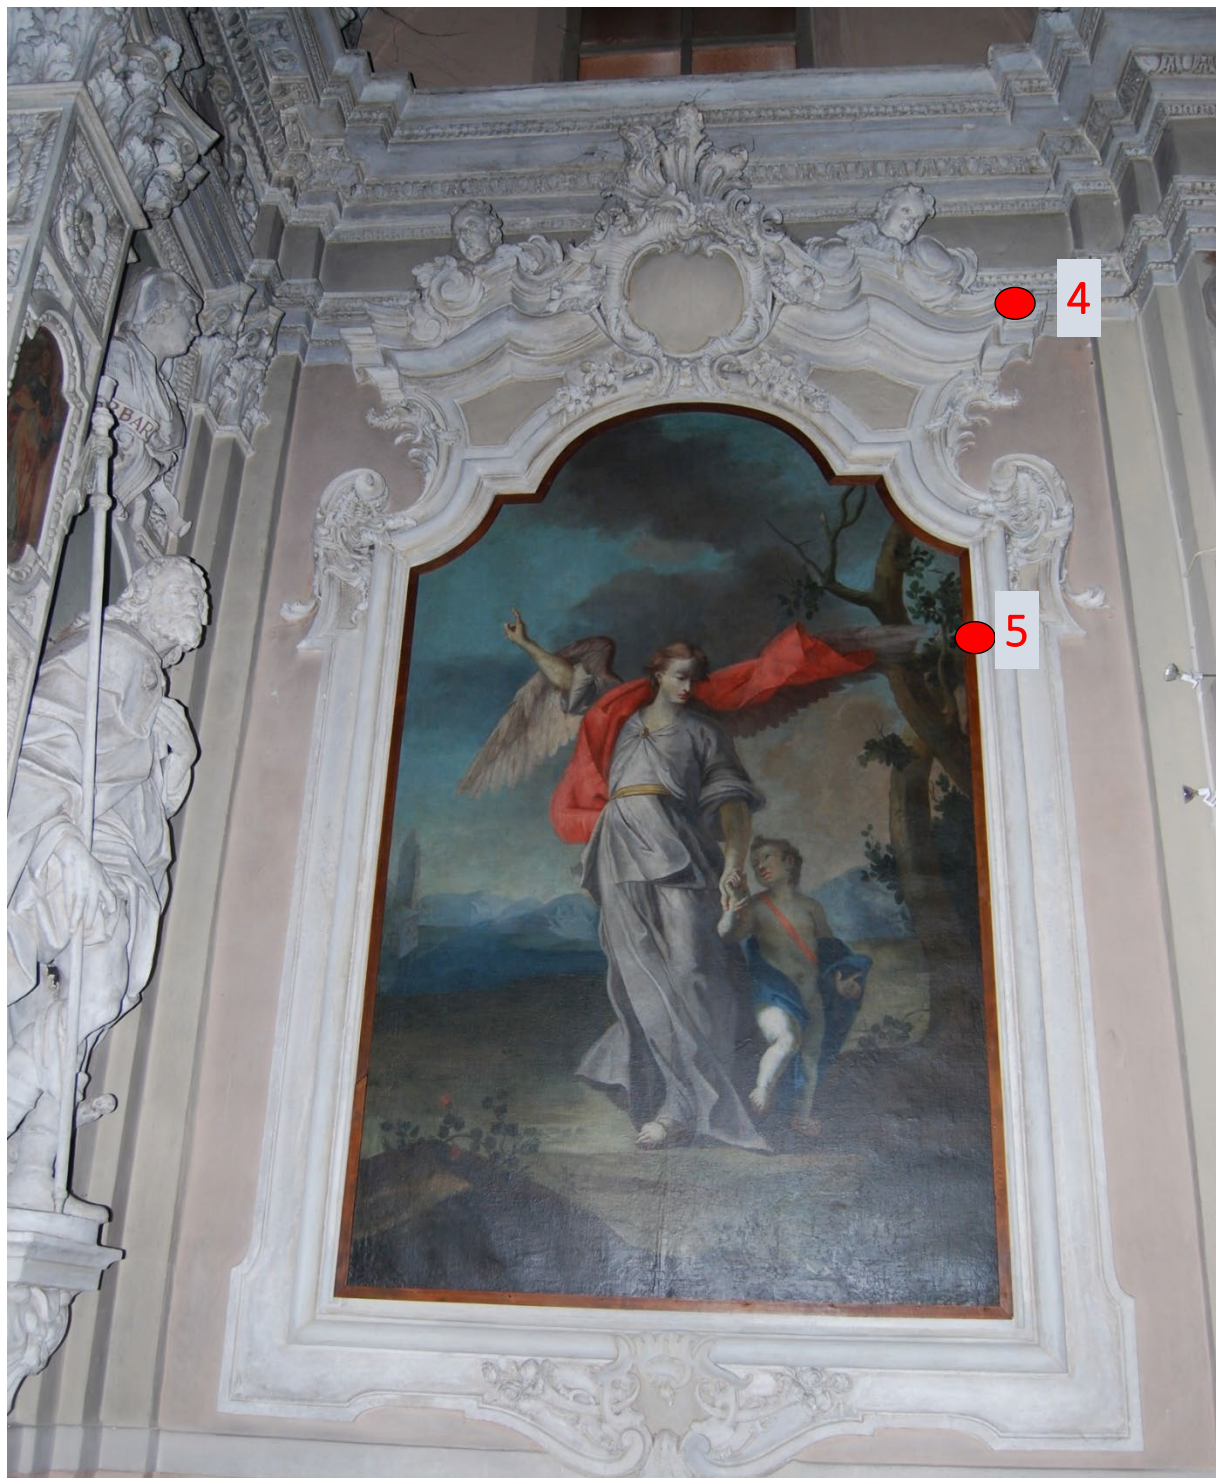
Rosario chapel, second sampling points

Frame stucco decoration belonging to 1700, in the Rosario Chapel.

Samples from the lateral cornice were also analysed. For the more **projecting part cornice**, the ground layer is composed of a magnesia-lime binder containing frequent and relatively large lime lumps, with gypsum consistently present. The lime-to-aggregate ratio is approximately 1:1. The aggregate consists of medium and fine sand with good sorting, and its composition includes flinty limestone, fragments of metamorphic silicate rocks, and gypsum fragments. The material shows medium porosity with rounded pore structures. The finishing layer has a magnesia-lime binder with frequent lime lumps, and gypsum. The L/A ratio is significantly greater than 1, resulting in a mixture composed almost entirely of binder. The aggregates consist of fragments of underburned limestone and gypsum.

In the case of the **linear frame**, the ground layer is characterized by an isotropic binder. Gypsum is not detected, and the lime-to-aggregate ratio is equal to or slightly less than 1. The aggregate is medium-grained and very well sorted, composed of fragments of metamorphic silicate rocks, quartz, feldspar, limestone, and micas. The porosity is high, with pores of irregular morphology. The finishing layer is extremely thin and consists of very fine silicate and calcareous sand.

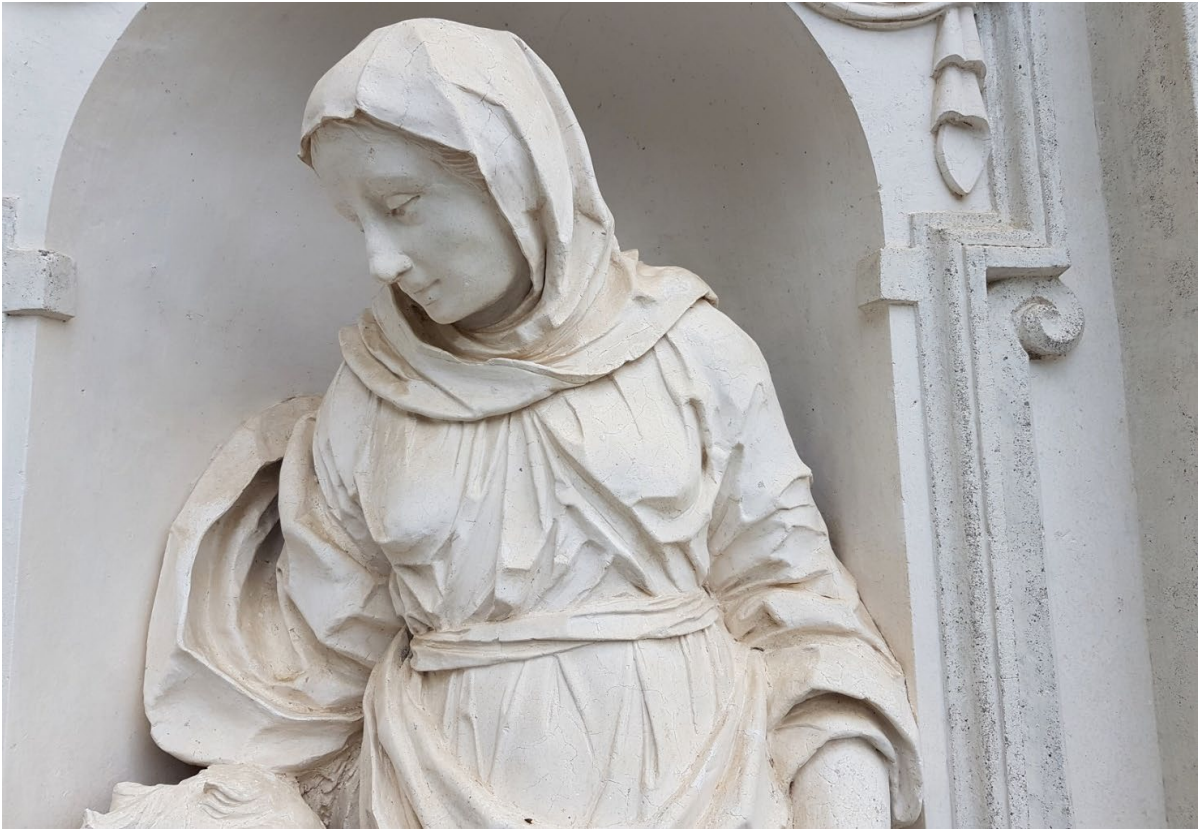
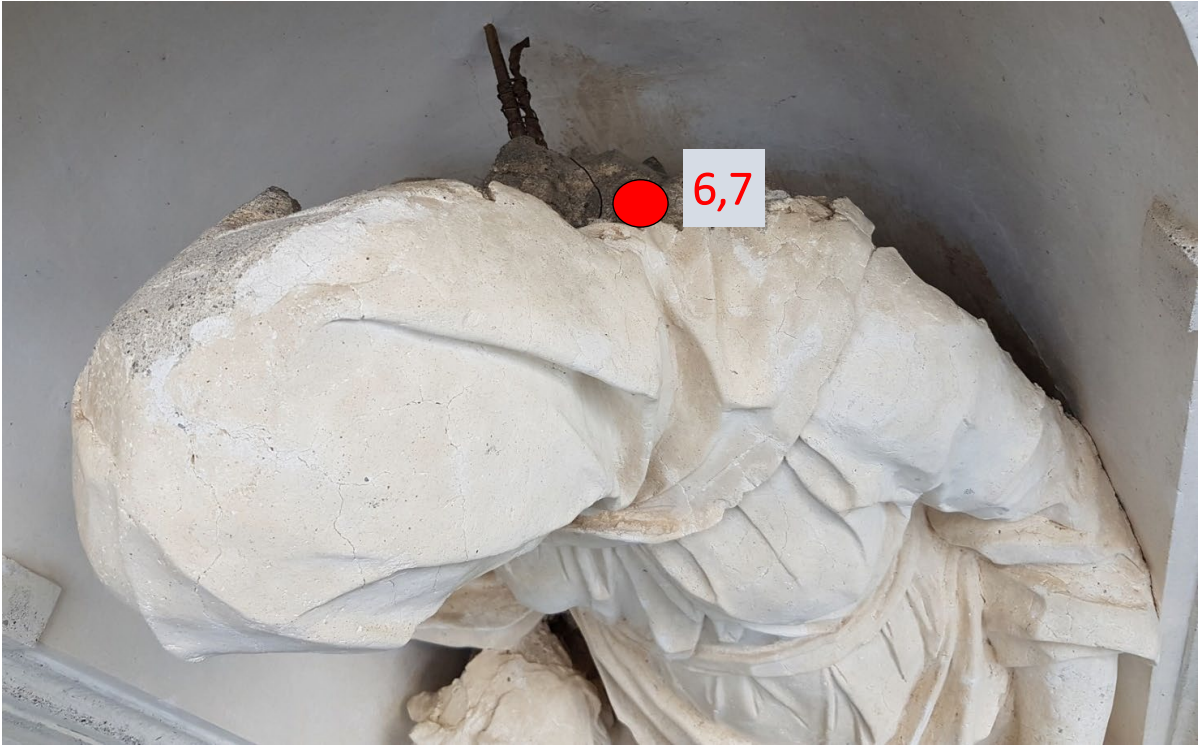
Facade, sampling points

Statue on the right external facade

The ground layer of the **external statue** consists of a magnesia-lime binder containing frequent lime lumps, with gypsum present throughout. The lime-to-aggregate ratio is approximately 1:1. The aggregate is coarse to very coarse with moderate sorting, and its composition includes flinty limestone, fragments of metamorphic silicate rocks, and gypsum particles. The stucco internal layer shows shrinkage cracks oriented perpendicular to the surface.

The finishing layer is composed of a magnesia-lime binder with frequent lime lumps. Gypsum is present, and the mixture is essentially pure binder. No aggregate is added, with the only inclusions being fragments of underburned limestone.

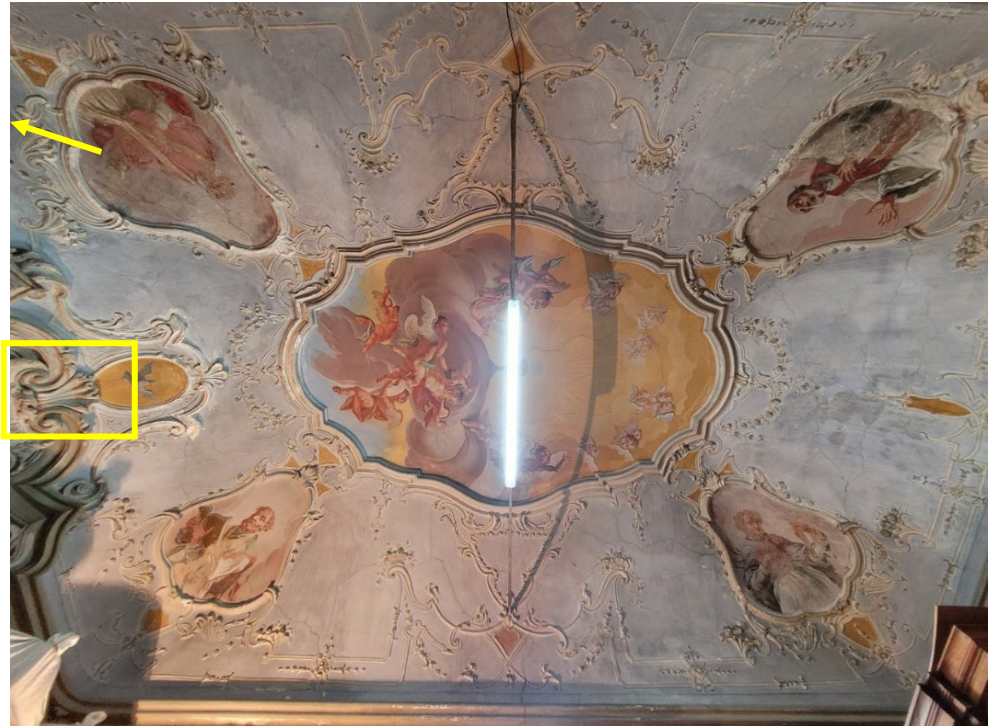
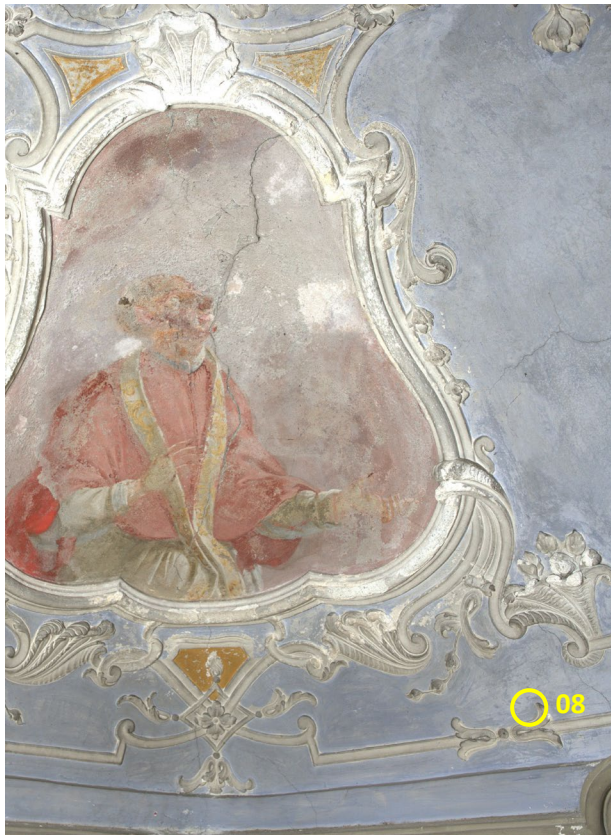
Old sacresty sampling points

Old sacresty, East side, external frame of the vault, sample 08.

All samples taken from the vault of the old sacristy consist predominantly of a finishing layer that contains only rare, small aggregates of varied colour. The plaster and stucco samples show a high degree of similarity.

The finishing layer is composed almost entirely of a Mg-lime binder, exhibiting a markedly heterogeneous texture with spherical features associated with the Mg-rich fraction of the binder, as well as frequent lime lumps. Radial hydromagnesite formations are also present.

The few aggregates observed consist mainly of quartz and iron oxides.

The paint layers applied to both the stucco decoration and the plaster consist of whitewash.

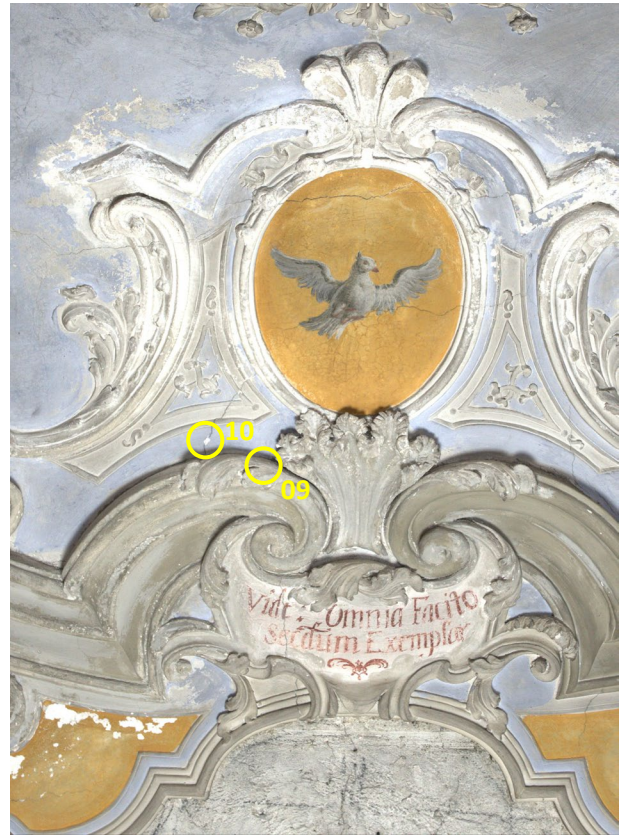
Old sacresty, East side, frame of the cartouche (sample 09) and vault background (sample 10).

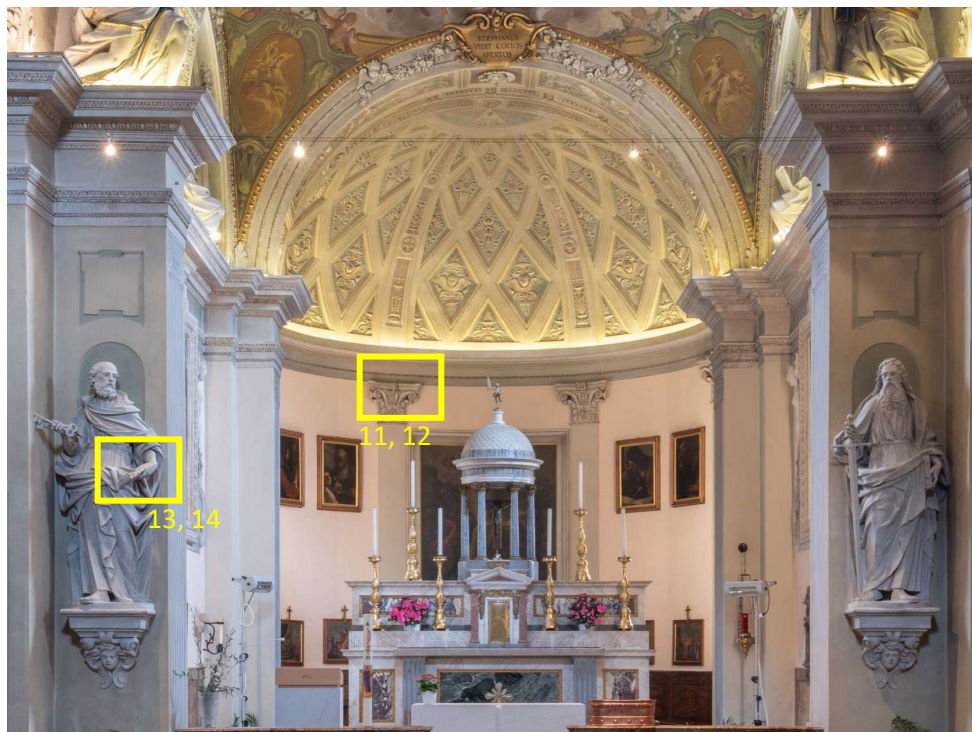
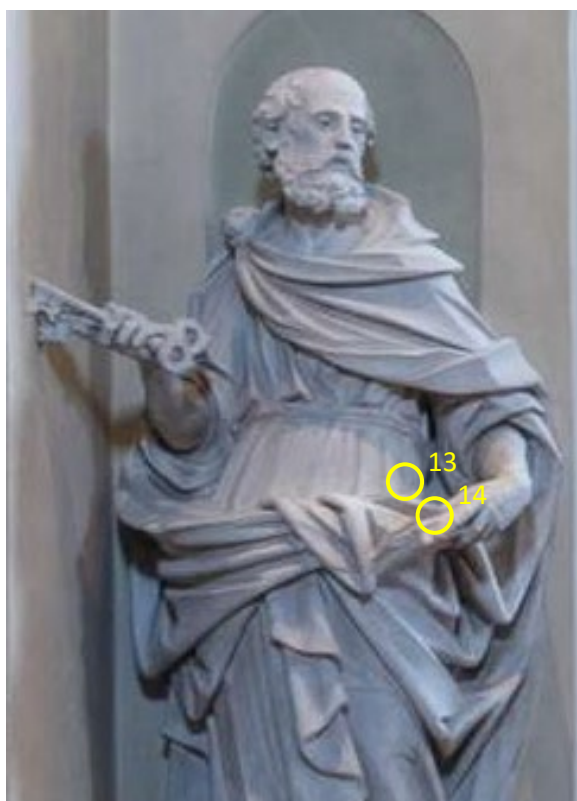
Choir and Triumphal wall - St Peter's Statue, sampling points

Triumphal wall, San Peter's statue, G. A. Colomba

The sample taken from the statue of Saint Peter (book) consists of a finishing layer composed of an Mg-lime binder displaying radial mineral phases and an aggregate formed of metamorphic rock fragments and limestone. This sample is extremely small, so the results can be not representative.

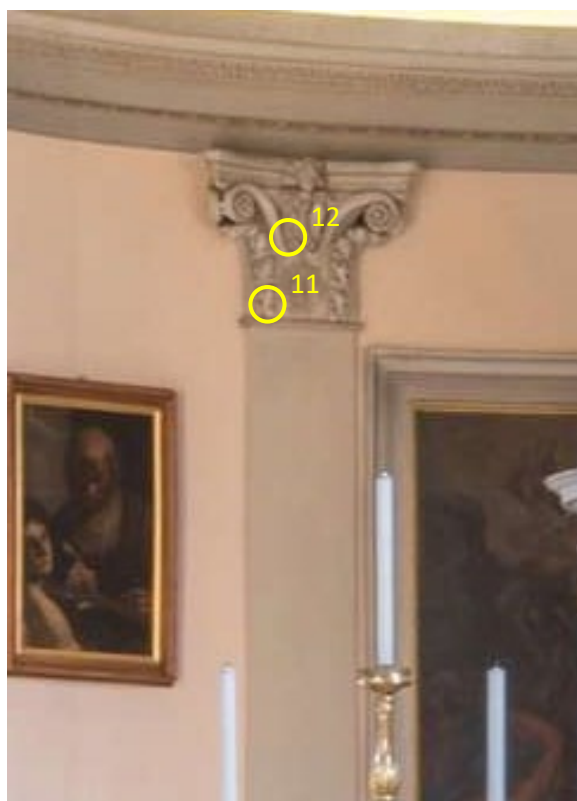
Decoration of the column capital in the choir

One sample taken from the **acanthus-leaf decoration** of the pilaster consists of a finishing layer and a ground layer. The ground layer containing quartz, stone fragments, selciferous limestone, and feldspar, showing characteristics very similar to those found in Iemale's chapel. The finishing layer is characterised by a Mg-lime binder with calcite aggregates.

A second sample from the same pilaster, collected from the central floral decoration, includes only a finishing layer, which is composed primarily of an Mg-rich binder with a small amount of calcite aggregate.

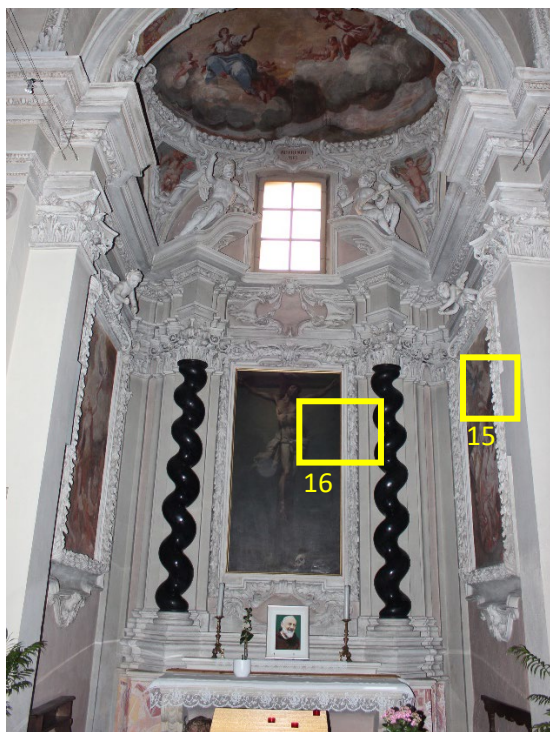
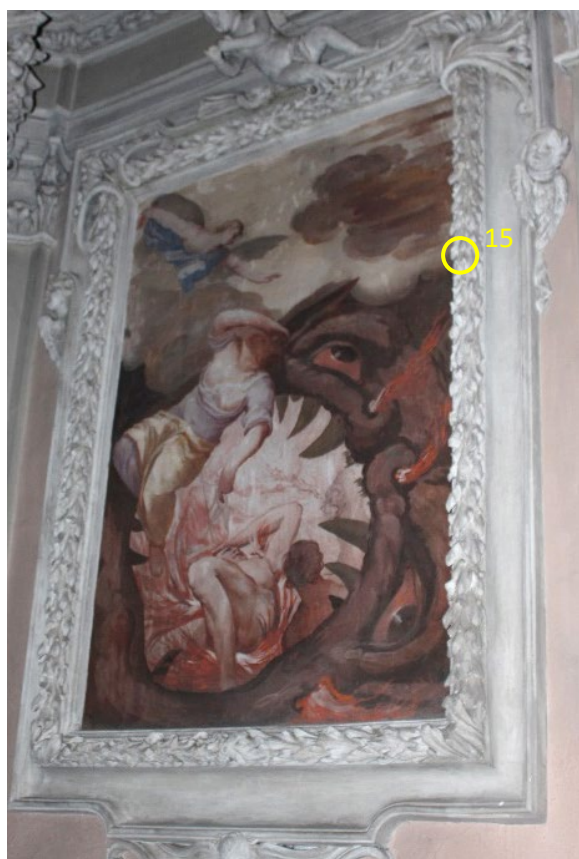
Chapel of the Suffrage, sampling points

Suffragio's Chapel, right frame, West side

The samples of the altar and the lateral frames of the **Suffragio chapel** are mainly composed of a finishing layer. It is almost entirely made up of Mg-lime binder, with very frequent lime lumps (binder-related particles) almost without sand aggregate. This specific presence of underburned BRP testifies that the heat treatment of the limestone was not sufficient and not efficient.
